**2006 SUPPLEMENTAL HYDROGEOLOGY
PROGRAM**

**WASTE MANAGEMENT CANADA INC.,
RICHMOND LANDFILL**

TOWN OF GREATER NAPANEE, ONTARIO

WESA File No. K-B5691 - 6
October 2008

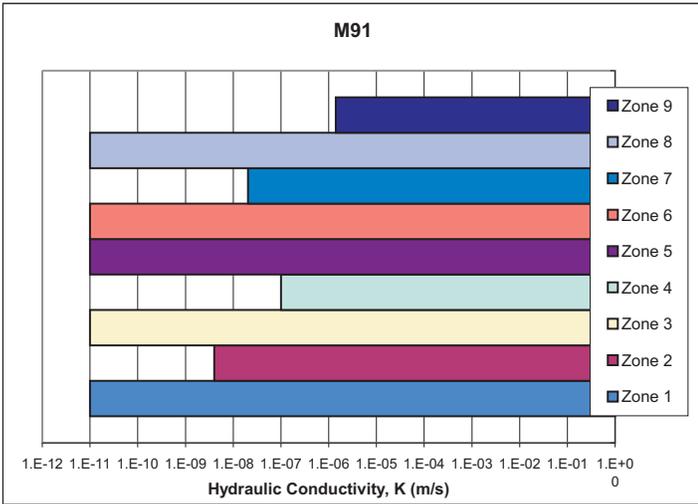
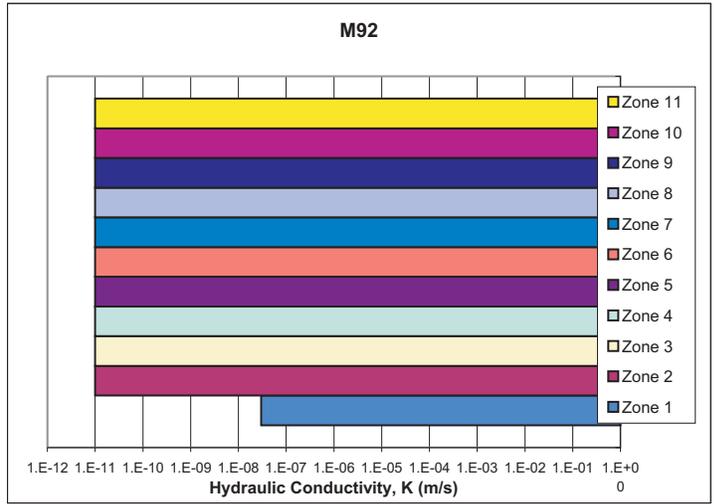
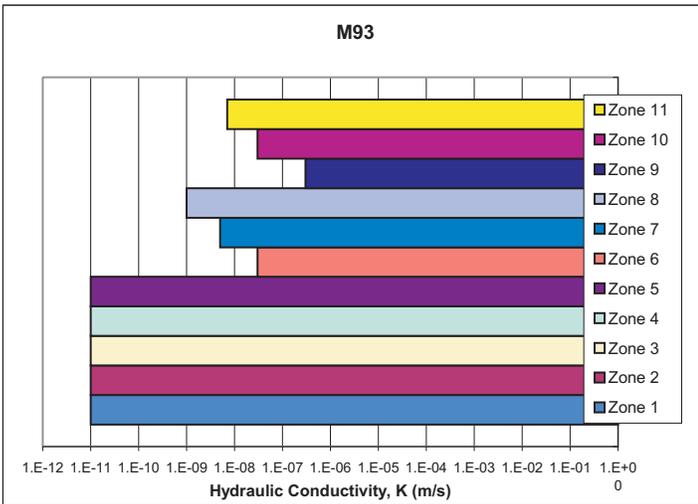
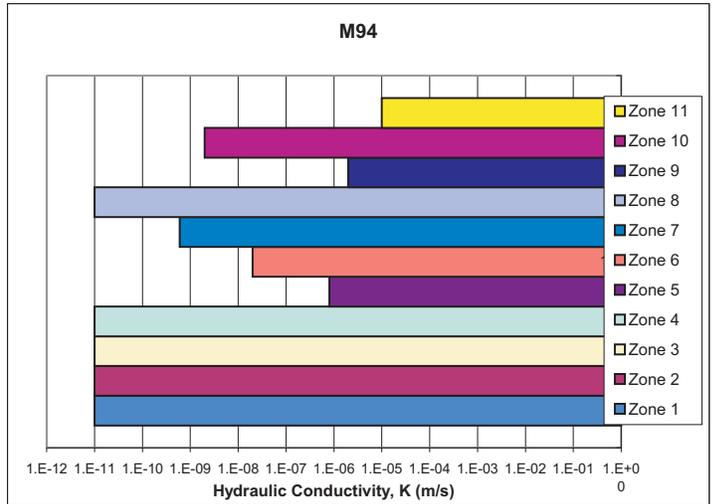
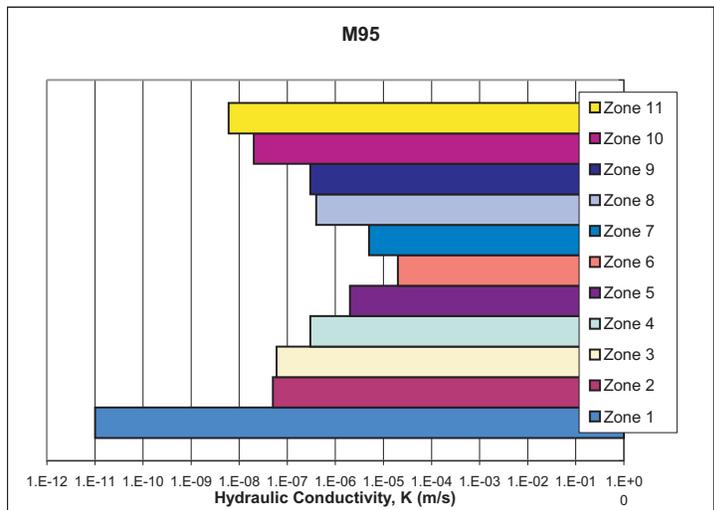
FIGURE: 2

The bulk rock hydraulic conductivities with depth for each borehole are illustrated on Figure 2. Examination of hydraulic conductivities with depth in each borehole indicates that in general (three of the five boreholes tested), zones of higher relative conductivity are found in the upper 10 metres of the bedrock. While the shallow bedrock exhibits higher relative borehole conductivities, in many cases the hydraulic conductivities of this zone are on the order of 10^{-7} to 10^{-9} m/s and are still considered to be of low permeability. This discrete shallow zone of relatively higher hydraulic conductivity was noted specifically at borehole locations M91, M93 and M94.

A second zone of elevated relative conductivity from approximately 12 to 18 mbgs was noted in two of the five boreholes: M93 and M94. Hydraulic conductivities for this interval range from 10^{-6} m/s at M94 to 10^{-8} m/s in M93. It should be noted that while this range of hydraulic conductivities is relatively high compared with overall conductivities measured on site, it is considered to be in the low to moderate range compared with general bulk rock conductivities. Within the boreholes M93 and M94, this interval is bounded above and below by low permeability bedrock with hydraulic conductivity values in the range of 10^{-9} m/s to 10^{-11} m/s. An exception to this distribution was noted in M91 and M95. In M91 elevated relative conductivities are observed as in the previous boreholes tested between 11.5 and 21.5 m bgs but a zone of very low hydraulic conductivity (less than 10^{-11} m/s) divides the zone and extends between 14.5 and 19 mbgs. The zone of very low hydraulic conductivity ultimately divides the second zone into two distinct zones of higher relative conductivities. M95 shows a zone of higher relative conductivities (between 10^{-5} to 10^{-8} m/s) extending from approximately 9.6 to 22 mbgs. This zone is isolated above and below by bedrock exhibiting decreasing hydraulic conductivities as one moves away (both up and down) from this relatively higher zone.

Zones of low to very low hydraulic conductivities were observed at depth in four of the five boreholes (M91, M93, M94 and M95). Test intervals with low hydraulic conductivities were observed between 20 and 30 mbgs in the boreholes tested. Hydraulic conductivities that define the zones range 10^{-9} to 10^{-11} m/s. Borehole M92 exhibited a unique distribution of hydraulic conductivity with depth (Figure 2). Hydraulic conductivities measured in the upper 27 metres of

the bedrock were less than 10^{-11} m/s. A zone of elevated relative hydraulic conductivity was noted between 27 and 29.5 mbgs at 10^{-7} m/s.

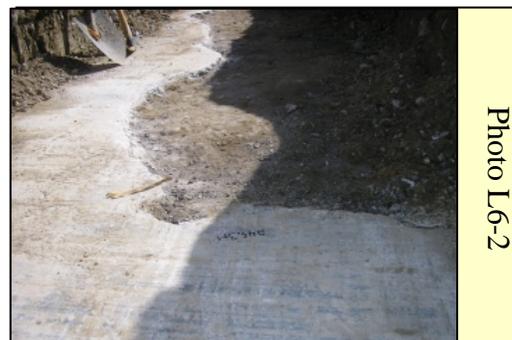
Photo L6-2

Weathered limestone surface at 245.3 m.

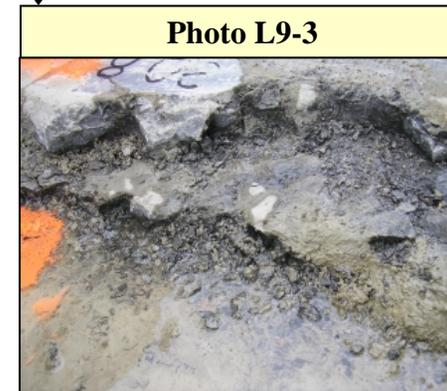
Bedding and water seepage at 30.8 m.

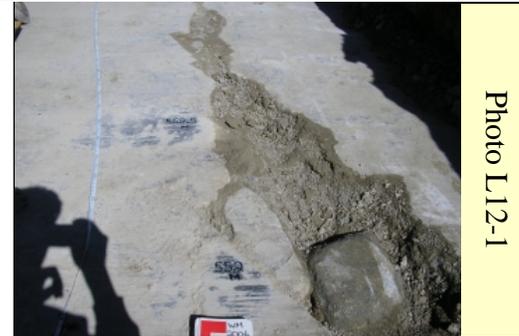
Photo L12-1

Till filled feature at 30 -35.25 m.

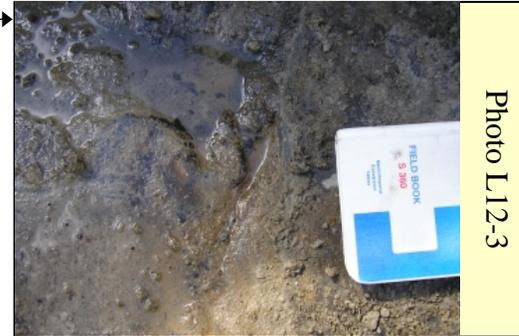
Photo L12-3

Small fracture with upward groundwater seep.

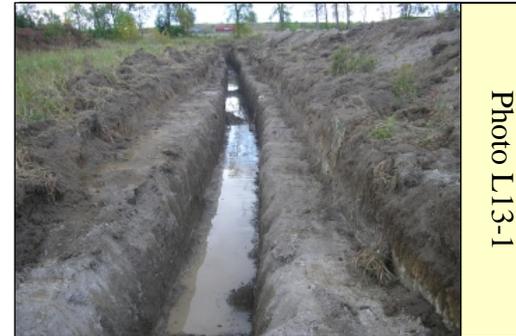
Photo L13-1

Trench L13 with GW seepage. Looking north.

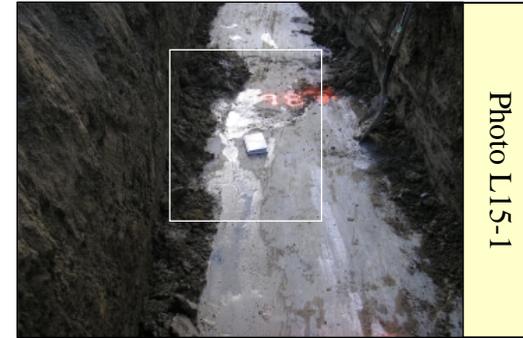
Photo L15-1

Small fracture with GW seepage.

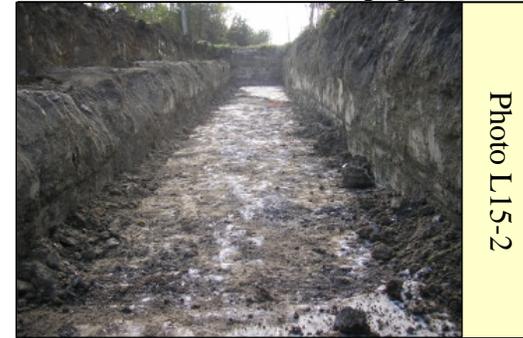
Photo L15-2

Weathered limestone bedrock surface.

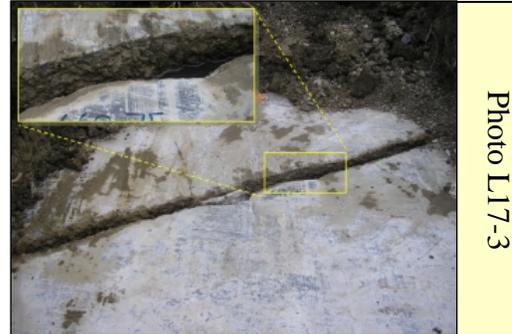
Photo L17-3

L-17	52.0	0.80 to 0.83	Generally smooth and unweathered with east-west glacial striations. One 12.8 m long section of weathered surface. One vertical fracture trending east-west.
L-18	60.0	0.47 to 0.88	Smooth and unweathered sections with east-west glacial striations. One 23 m long section of weathered surface. One vertical fracture trending NW-SE.

Vertical fracture at south end of trench.

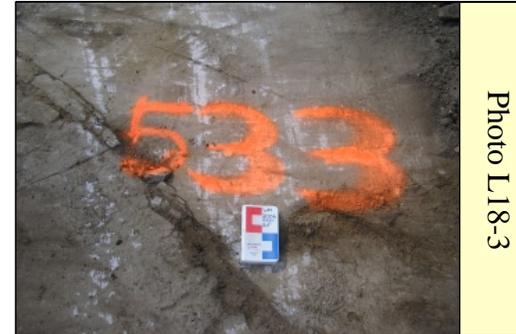
Photo L18-3

Vertical fracture near south end of trench.
