MEMORANDUM

DATE: December 16, 2008
TO: Christopher Prucha (WM)
C.C.:
FROM: François Richard (WESA)
PROJECT #: K-B5691-6
SUBJECT: **WM Richmond Landfill: Groundwater Flow in the Zone 3-10 m below Top of Bedrock**

**Figure 1:
Groundwater Elevations in 3-10 m below bedrock zone
October 2008**

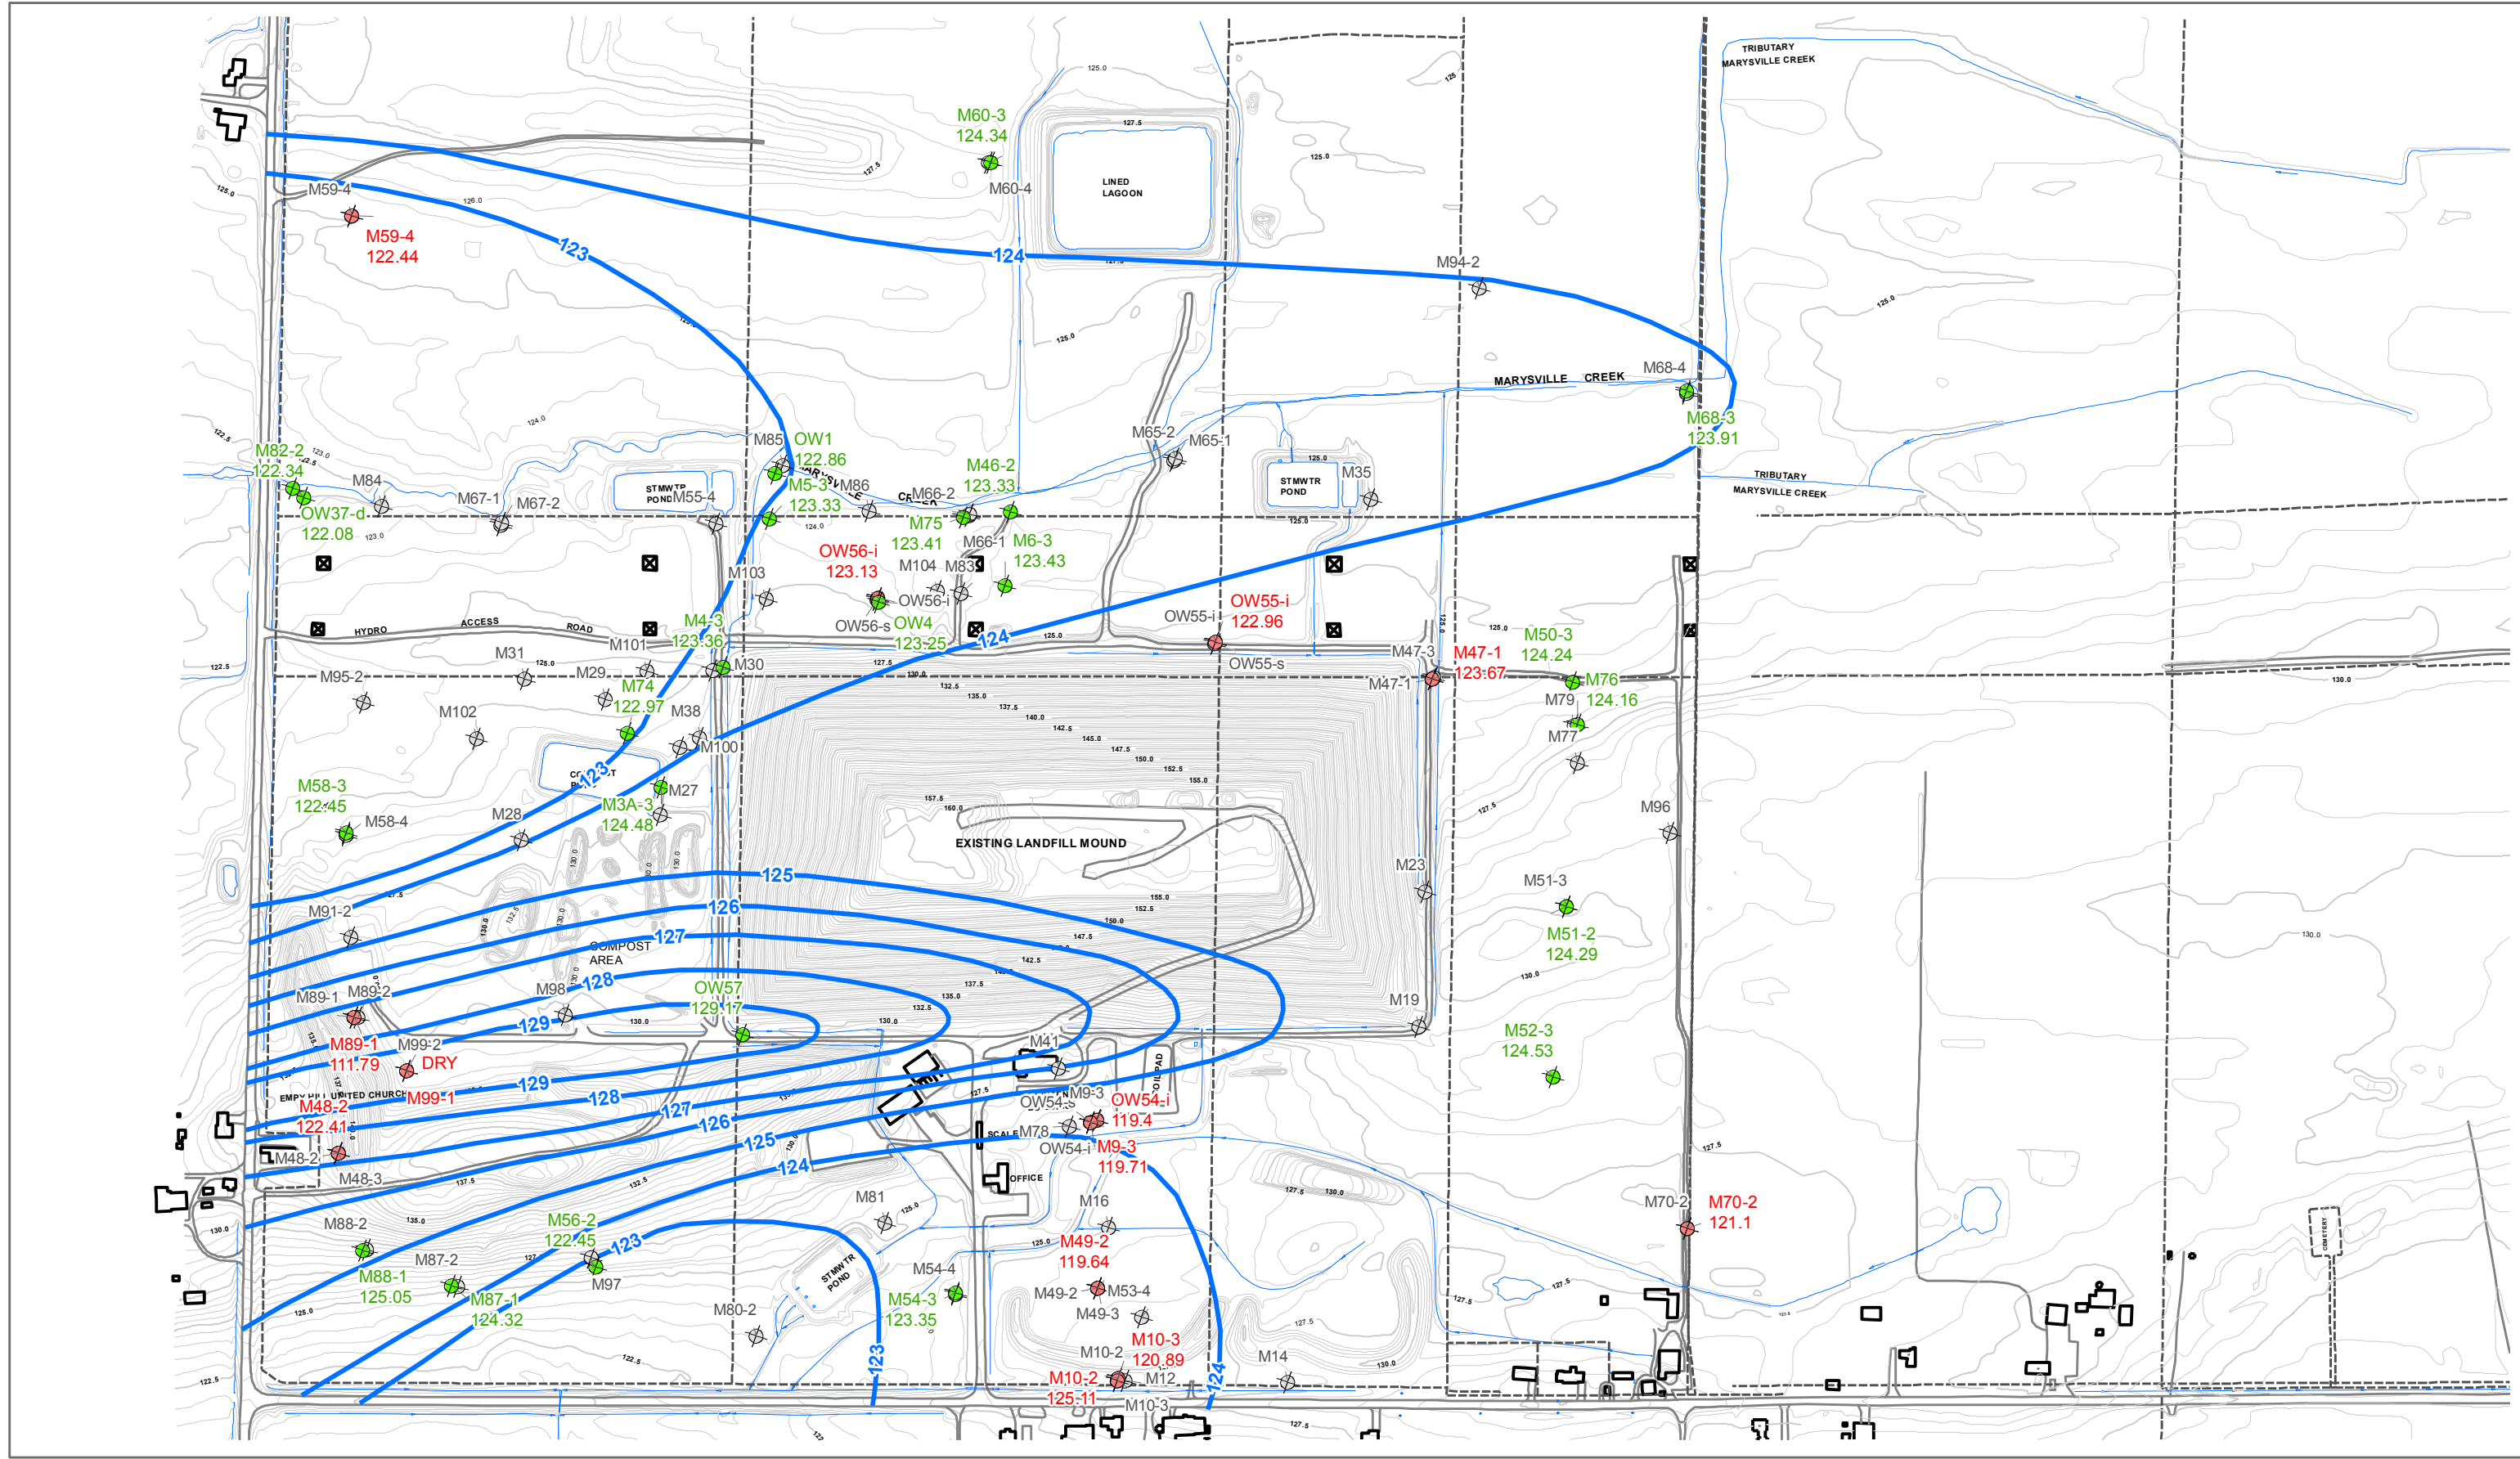
Figure 1 identifies the monitors screened in the 3-10 mbBR zone, along with groundwater elevations measured on October 14, 2008. Monitors suitable for contouring are shown in green, while monitors not suitable for contouring are shown in red. Suitable water levels were

contoured, and confirm that water levels in the 3-10 mbBR hydrostratigraphic unit are consistent with previous interpretations presented of shallow groundwater flow directions, most recently in a figure presented during the meeting (October 2008 groundwater elevations and contours), and previously in WESA (2008)¹ for groundwater elevations measured on June 27, 2008. In particular, the groundwater divide running approximately parallel to the Empey Hill drumlin has an influence on groundwater flow directions down in the 3-10 mbBR interval. Note that monitoring wells M6-3, OW1 (both located to the north of the landfill) and OW57 (located at the southwest corner of the landfill), have historically been used in the contouring for the uppermost hydrostratigraphic unit; they are also used in the contouring of the 3-10 mbBR unit since they are screened in this zone.

Based on the information above, it can be concluded that the saturated overburden and the upper 10 mbBR behave as a single monitorable hydrostratigraphic unit. The interpreted shallow groundwater flow directions show minimal differences in the 3-10 mbBR zone compared to the shallower zone. It is therefore appropriate to use groundwater monitors screened in the overburden and/or in the upper 10 metres below the bedrock surface to characterize shallow groundwater flow at the Richmond Landfill.
