## MEMORANDUM

**DATE:** March 30, 2023  
**TO:** Trevor Dagalys, District Manager, Ministry of the Environment, Conservation and Parks (MECP)  
**CC:** Craig Dobiech (MECP)  
Chris Prucha, Noah Wayt and Chad Moose (WMCC)  
**FROM:** François Richard (BluMetric)  
**PROJECT NO:** 230130-03  
**SUBJECT:** Notification of On-Site Leachate Release, WM Richmond Landfill, Town of Greater Napanee  
**Ref: MECP Spill Action Centre Reference Number: 1-33QFLL**

**WASTE MANAGEMENT RICHMOND LANDFILL LEACHATE RELEASE INVESTIGATION**

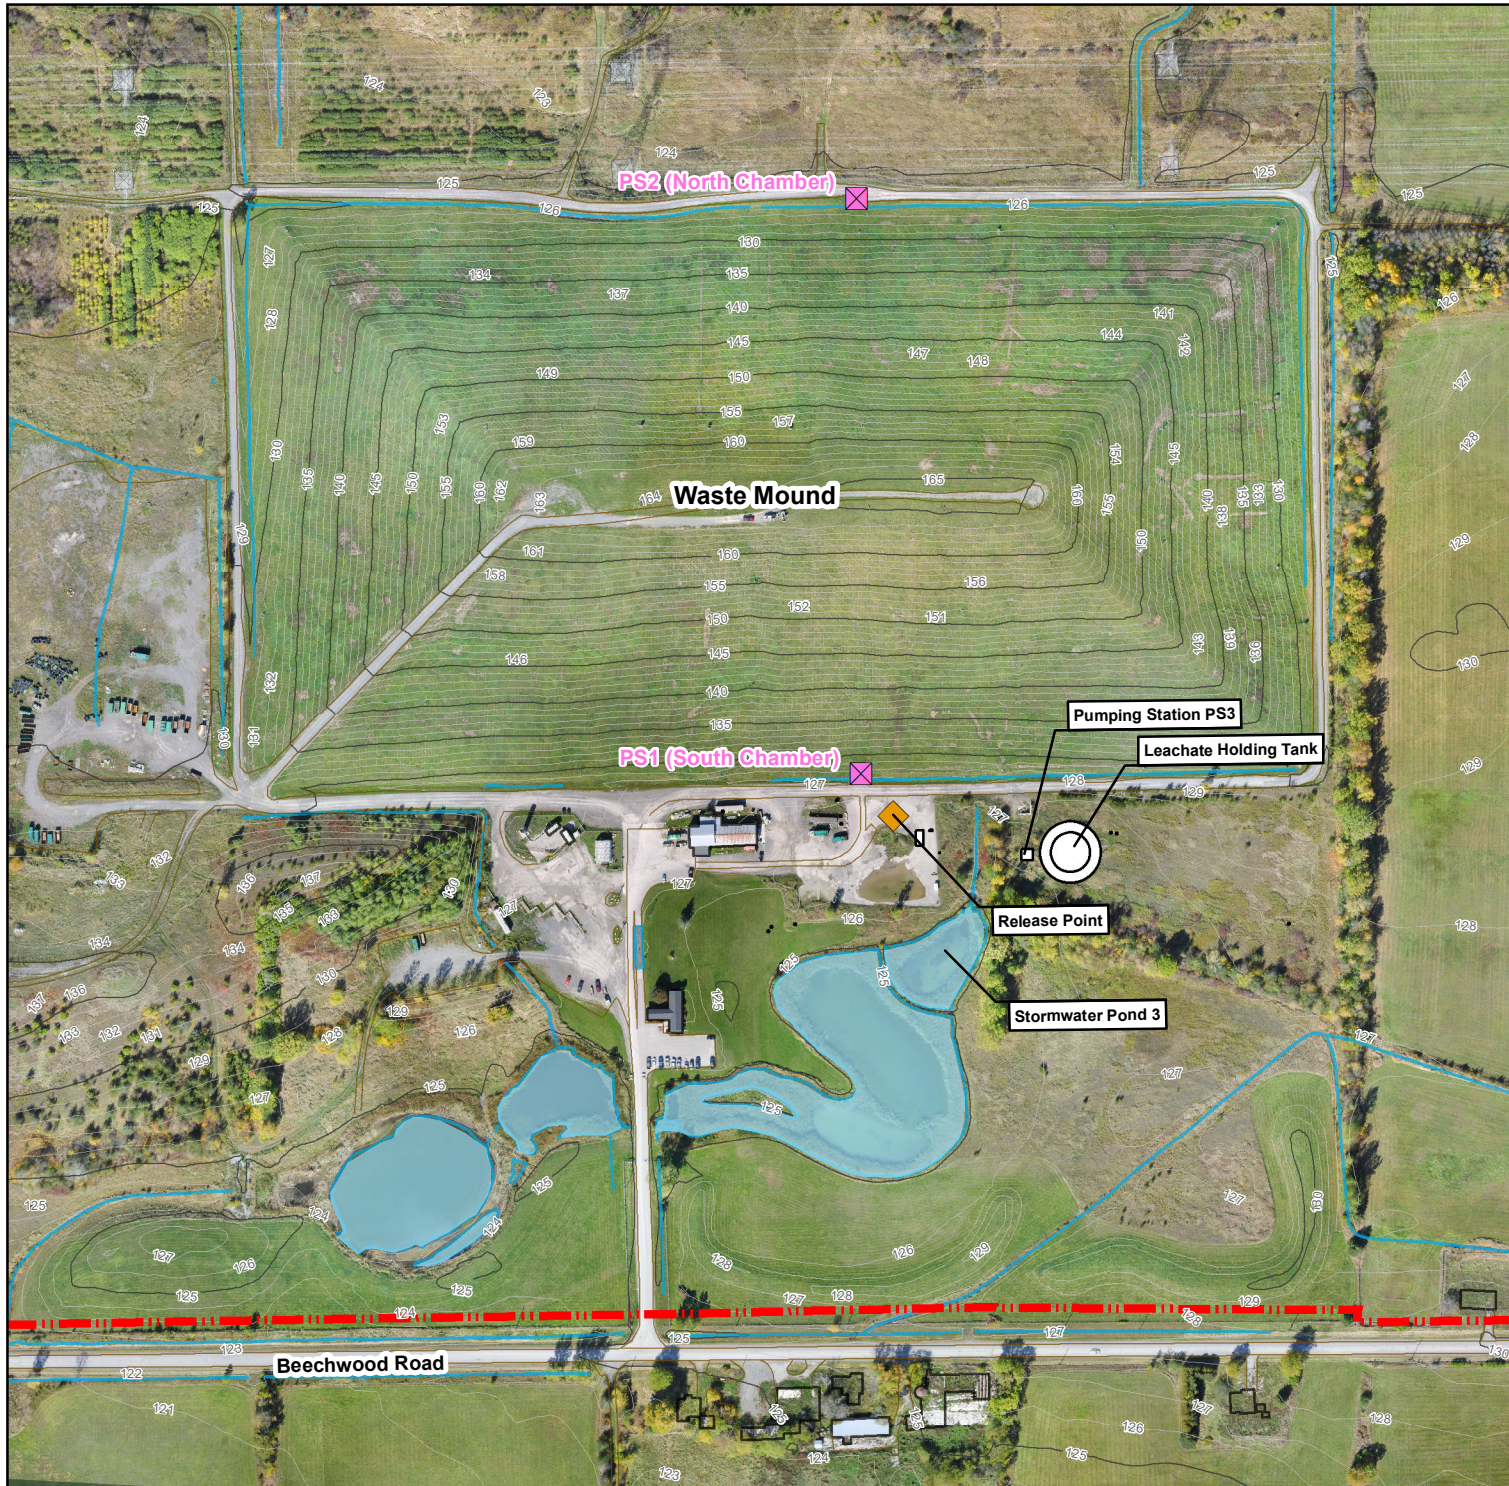
<b>PROJECT #</b> 230130-06		<b>DATE</b> March 30, 2023	
<b>DRAWN</b> GM	<b>CHECKED</b> FR	<b>FIG NO.</b> 01	<b>REV</b> 0

Upon arrival on-site at 8:30 AM on Monday March 27, 2023, BluMetric field personnel observed moisture originating under the in use temporary frac tank. Closer examination revealed a small drip leak on the under belly of the tank. The location of the release is shown on **Figure 1**. Upon discovery and as discussed further below, BluMetric personnel immediately implemented initial corrective actions to stop the release by coordinating with the leachate hauler to transfer leachate from the damaged frac tank to another frac tank already on-site.

Once the release was stopped, BluMetric personnel investigated the area and was able to confirm that the release was limited to the asphalt surface and gravel area immediately adjacent to the temporary frac tanks. The release did not leave the site or enter any stormwater feature. The impacted area was determined based on visual inspection of the rust-colored stains to be relatively limited in lateral extent (approximately 20 m<sup>2</sup>). Photo documentation of area of the release is provided as **Attachment A**. Based upon the remaining volume in the tank at the time of discovery, it is estimated that approximately 8.9 m<sup>3</sup> of leachate leaked onto the ground.

**SITE PLAN AND MARCH 2023 RELEASE LOCATION**

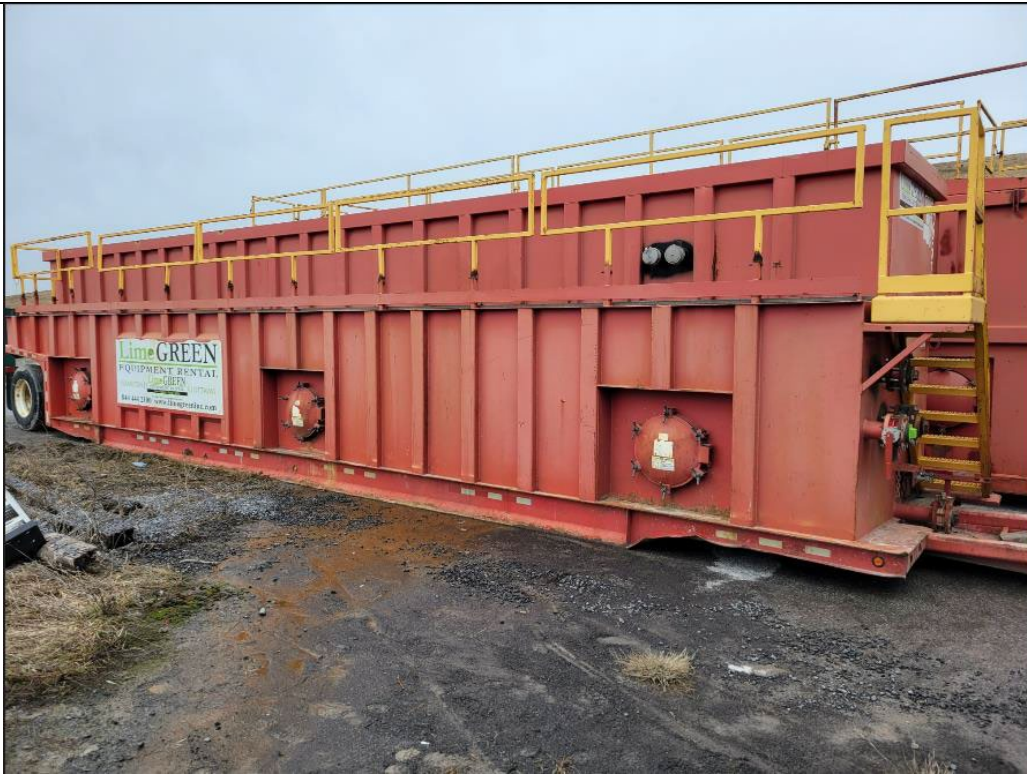
Photograph 1 (March 27, 2023). Frac tank showing evidence of leakage (rust coloured staining on ground).

As discussed above and to mitigate the active release, corrective action measures were undertaken immediately upon discovery by BluMetric personnel. A vacuum truck was mobilized to the site and utilized to transfer leachate from the defective tank into a second emergency frac tank. This was completed by approximately 11:00 AM. Meanwhile, the release was reported through the MECP Spills Action Centre, and the Kingston District Office was notified. As follow-up, MECP Environmental Officer, Craig Dobiech, mobilized to the site at approximately 1:15 PM, to investigate the release.

The area affected is limited and contained. Initial cleanup was completed manually on March 27, 2023, by scooping visually impacted gravel. A local contractor was contacted and visited the site on March 28, 2023, to assess the affected area to determine the proper cleanup activities, scheduled to take place on Thursday March 30, 2023. Since the release is limited to one area, the top layer of visually impacted gravel and soils will be stripped, consolidated into a pile onto a polyethylene sheet and covered with tarps, tested and then disposed of at an approved facility. Once the affected

gravel and soils have been removed, the area will be graded, and new gravel will be laid down to bring this area back to the original grade and condition.

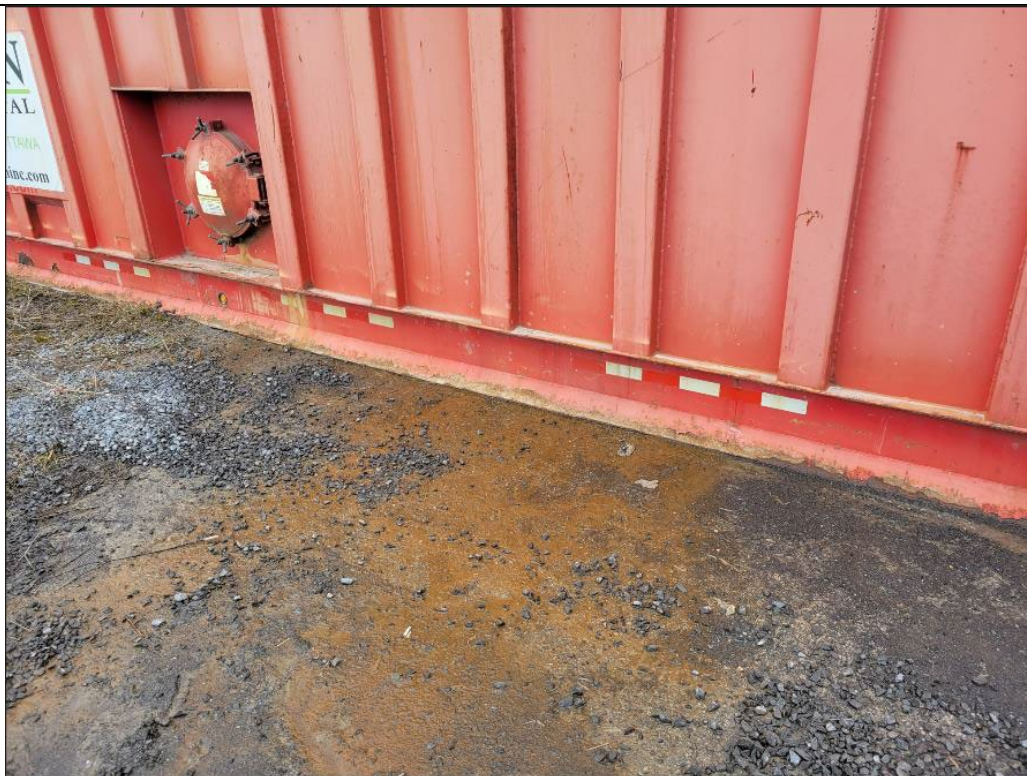
Photograph 2 (March 27, 2023). Frac tank showing evidence of leakage (rust coloured staining on ground).

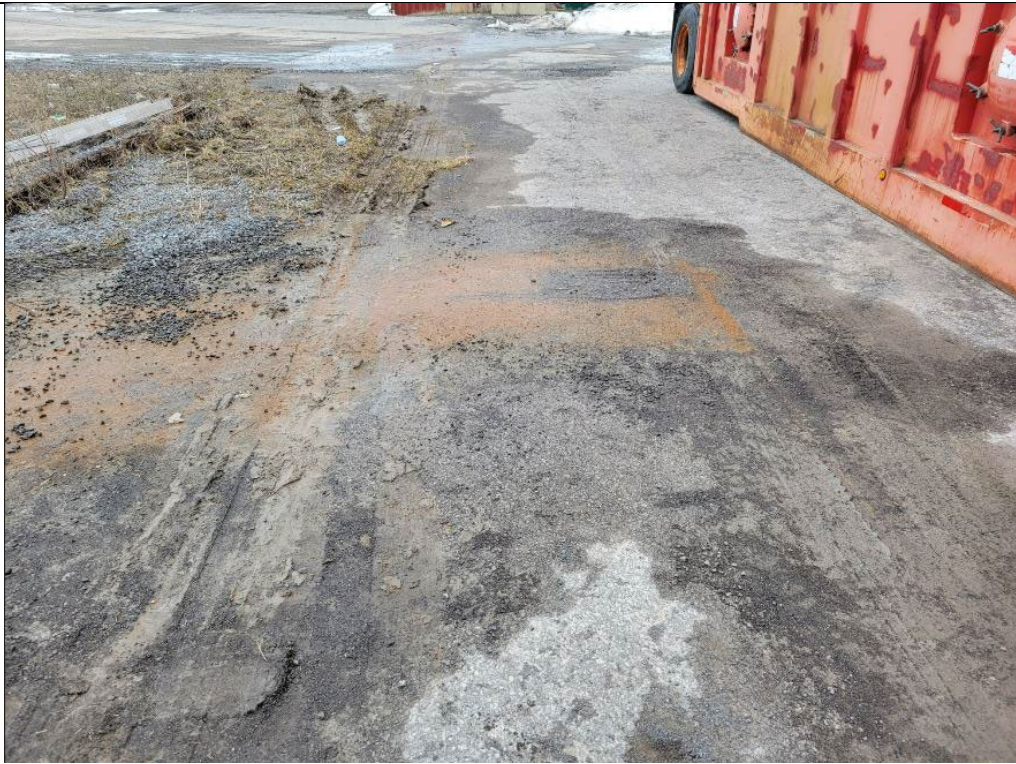
**Photograph 3 (March 27, 2023).** Evidence of leakage following tank removal.

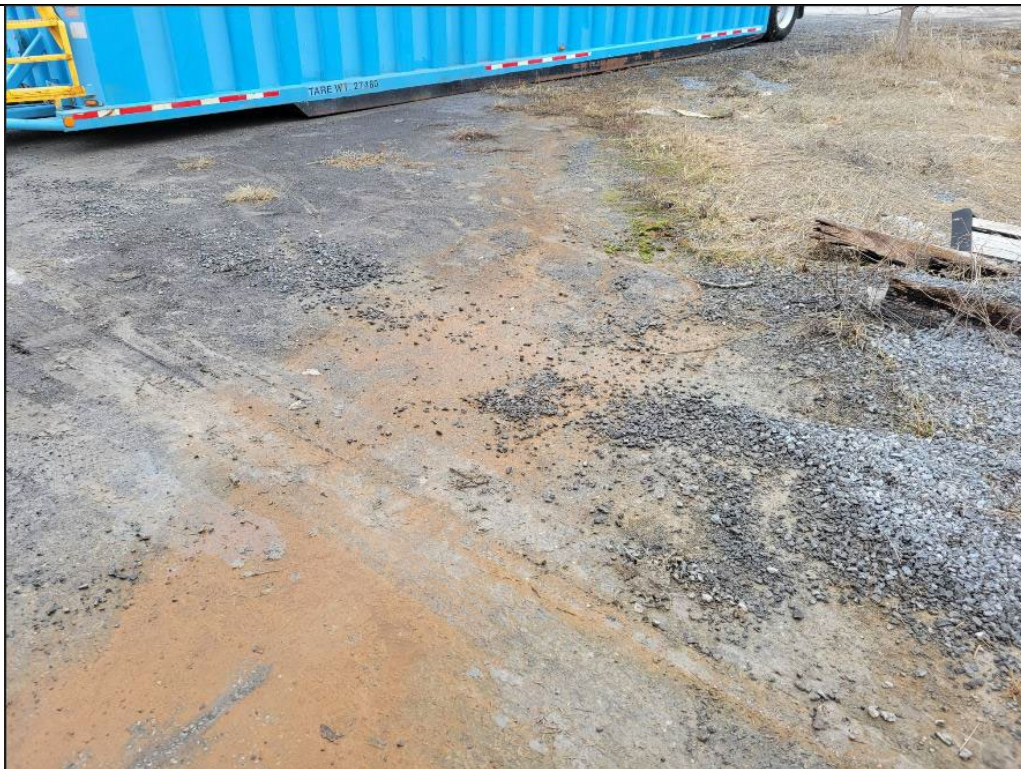
**Photograph 4 (March 27, 2023).** Evidence of leakage following tank removal.

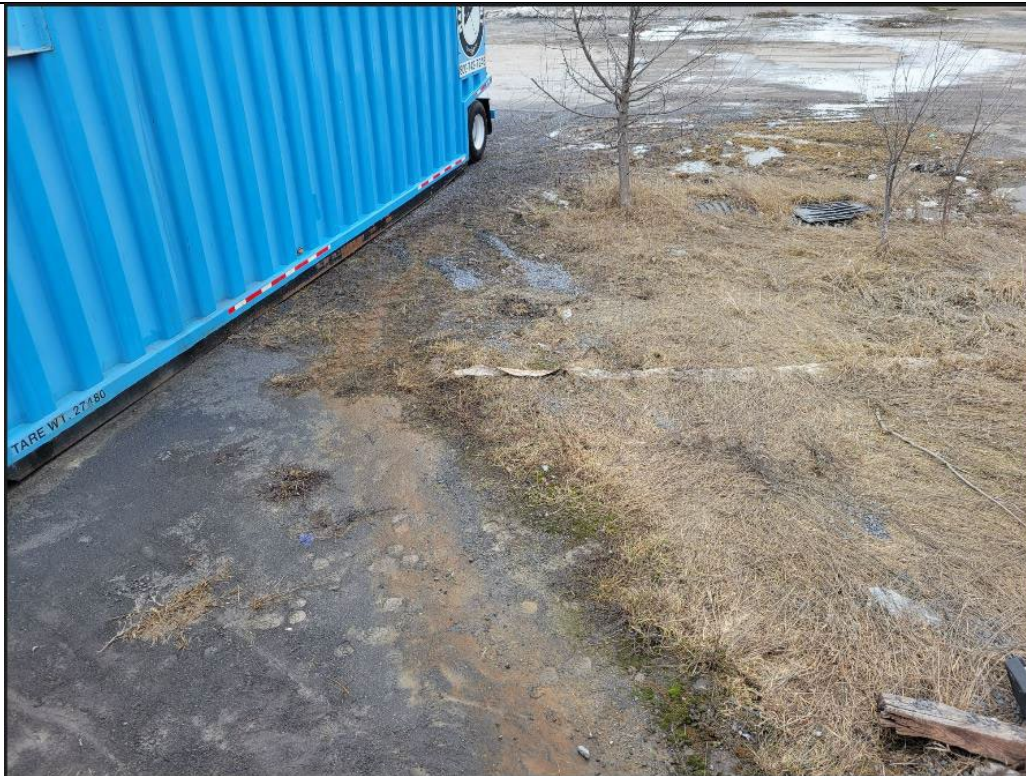
**Photograph 5 (March 27, 2023).** Evidence of leakage following tank removal.
