RICHMOND SANITARY LANDFILL SITE, MONITORING REPORT NO. 34

PART OF LOTS 1, 2 AND 3, CONCESSION IV,
TOWN OF GREATER NAPANEE, COUNTY OF
LENNOX AND ADDINGTON

MARCH 25, 2021

Subject: Waste Management of Canada Corporation - Richmond Landfill Site Annual Monitoring Report #34

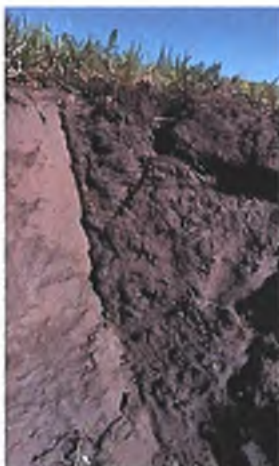
Test Pit ID: TP1-20 Date: 2020-05-20
Excavated by: Tomlinson Environmental Easting: 335566
Method: Kubota KX980 Track-mounted Excavator Northing: 4903010

Interval Depth (m bgs)	Stratigraphy	Sample				
		Topsoil Thickness (m)	Cover Soil Thickness (m)	Shelby Tube Sample Interval (m bgs)	Recovery (m)	Analyses
0 - 0.12	TOPSOIL - root system extending to 0.18m. Moist.	0.12		0.00-0.70	0.26	Density/Natural Moisture Content
0.12-0.80	SILTY CLAY - grey brown, moist.		1.18			
0.80-1.30	FILL - Grey, Brown, Black fill with trace garbage, large rock pieces. Small seep observed in bottom of TP.			0.70-1.25	0.18	Density/Natural Moisture Content
Comments:						
Grab sample collected from 0.20 - 0.60 m bgs.						
Photos:

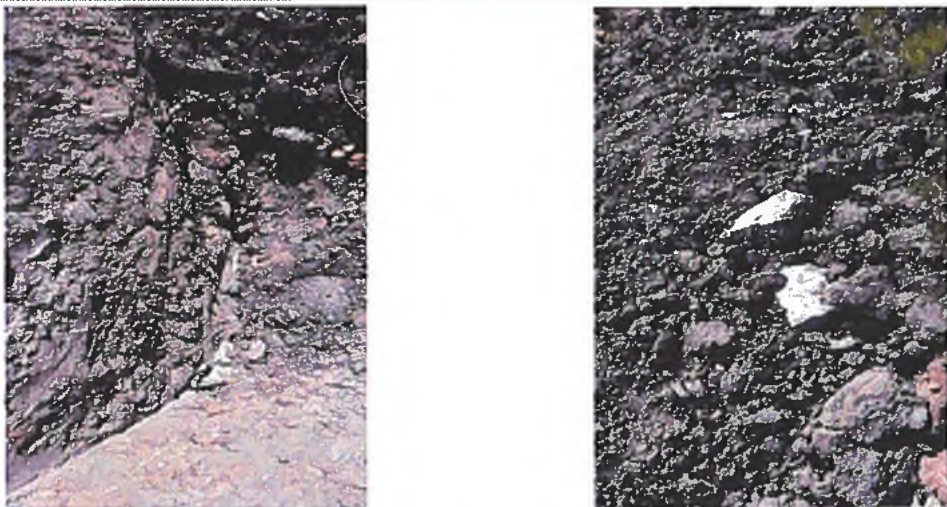
Test Pit ID: TP2-20 Date: 2020-05-20
Excavated by: Tomlinson Environmental Easting: 335555
Method: Kubota KX080 Track-mounted Excavator Northing: 4903061

Interval Depth (m bgs)	Stratigraphy	Sample				
		Topsoli Thickness (m)	Cover Soil Thickness (m)	Shelby Tube Sample Interval (m bgs)	Recovery (m)	Analyses
0 - 0.28	TOPSOIL - root system extending to 0.15m. Dry.	0.28				
0.28-0.75	SILTY CLAY - grey, dry.		0.96			
0.75-1.24	FILL - Large rock pieces with cobbles, some garbage. Dry.					
1.24-1.40	FILL - Garbage, dry.					
Comments:						
TP2 was excavated in area previously repaired. Surface material was dry with no grass growth.						
Photos:

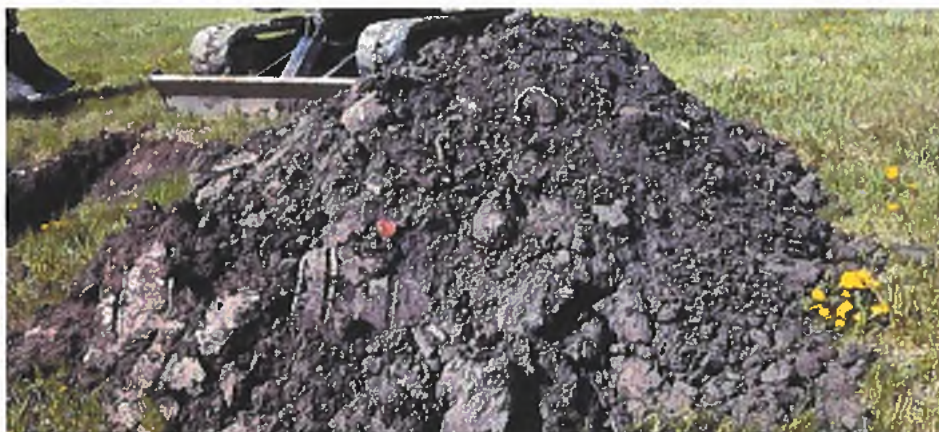
Test Pit ID: TP3-20 Date: 2020-05-20
Excavated by: Tomlinson Environmental Easting: 335538
Method: Kubota KX080 Track-mounted Excavator Northing: 4903065

Interval Depth (m bgs)	Stratigraphy	Sample				
		Topsoli Thickness (m)	Cover Soil Thickness (m)	Shelby Tube Sample Interval (m bgs)	Recovery (m)	Analyses
0 - 0.18	TOPSOIL - root system extending to 0.08m. Dry.	0.18				
0.18-0.66	SILTY CLAY - brown, grey. Dry.		0.82	0-0.70	0.23	Grain size (sieve/hydrometer), Density/Natural Moisture Content
0.66-1.40	FILL - Silty clay, some birch and rocks. Mixed with garbage at 1.0m bgs. Dry.			0.3-1.0	0.30

Possible waste visible at surface. Grass covered. Grab sample collected from 0.20 - 0.60 m bgs.

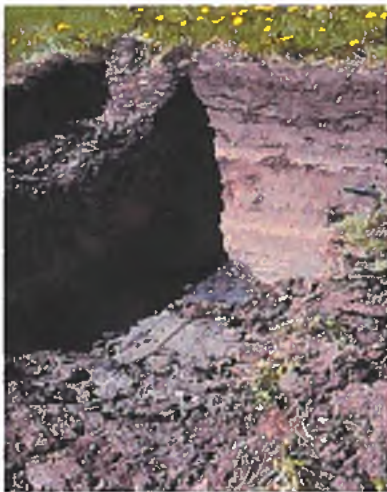
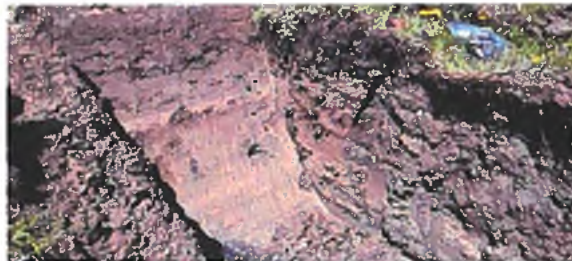
Test Pit ID: TP4-20 Date: 2020-05-20
Excavated by: Tomlinson Environmental Easting: 335484
Method: Kubota KX080 Track-mounted Excavator Northing: 4903044

Interval Depth (m bgs)	Stratigraphy	Sample				Analyses
		Topsoil Thickness (m)	Cover Soil Thickness (m)	Shelby Tube Sample Interval (m bgs)	Recovery (m)	
0 - 0.24	TOPSOIL - root system extending to 0.32m	0.24				
0.24-1.34	CLAY- Brown, grey, Dry. Garbage encountered at 1.34m bgs.		1.10	0-0.70	0.29	Grain size (sieve/hydrometer), Density/Natural Moisture Content
				0.70-1.4	0.37

Grass at surface. Very consistent clay layer.

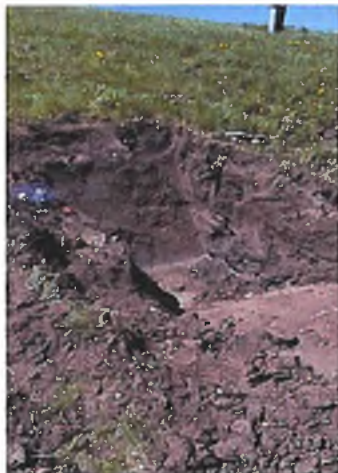
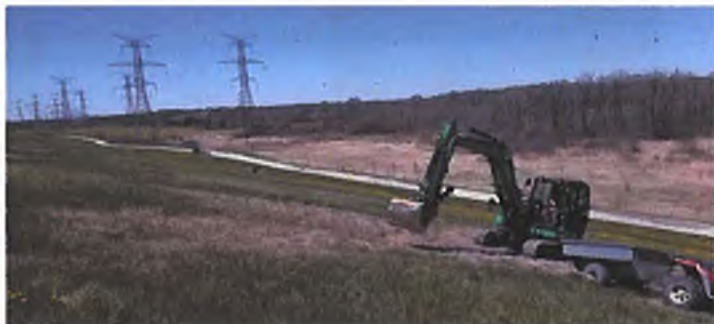
Test Pit ID: TP5-20 Date: 2020-05-20
Excavated by: Tomlinson Environmental Easting: 335500
Method: Kubota KX080 Track-mounted Excavator Northing: 4903118

Interval Depth (m bgs)	Stratigraphy	Sample				
		Topsoil Thickness (m)	Cover Soil Thickness (m)	Shelby Tube Sample Interval (m bgs)	Recovery (m)	Analyses
0 - 0.18	TOPSOIL - root system extending to 0.20m.	0.18				
0.18-0.78	FILL - silty clay with gravel, large rock pieces and garbage (plastic, fabric, metal).		1.36			
0.78-1.54	CLAY - Brown, turning to grey at 1.30m bgs.					
Comments:						
Grassy surface. Grab samples collected from 0.30 - 0.50 m bgs and 1.00 - 1.40 m bgs.						
Photos:						
<div>

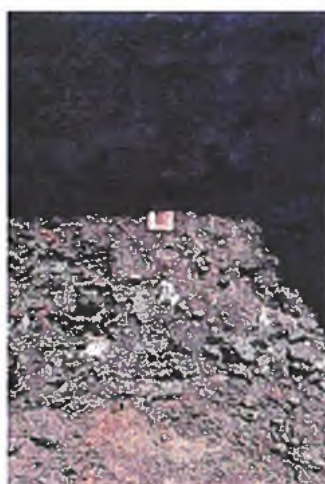
Test Pit ID: TP6-20 Date: 2020-05-20
Excavated by: Tomlinson Environmental Easting: 335478
Method: Kubota KX080 Track-mounted Excavator Northing: 4903163

Interval Depth (m bgs)	Stratigraphy	Sample				
		Topsoil Thickness (m)	Cover Soil Thickness (m)	Shelby Tube Sample Interval (m bgs)	Recovery (m)	Analyses
0 - 0.15	TOPSOIL - Brown, root system extending to 0.10m.	0.15	1.49	0.0-0.70	0.32	Grain size (sieve/hydrometer), Density/Natural Moisture Content
0.15-0.64	CLAY- Grey, blocky, trace gravel, dry.					
0.64-1.64	FILL - soil with some garbage (plastic and brick)					
Comments:						
Stressed vegetation observed at surface. Grab sample collected from 0.20 - 0.40 m bgs. No grab sample in lower portion of test pit due to presence of hydrocarbon or landfill gas.						
Photos:						
<div>

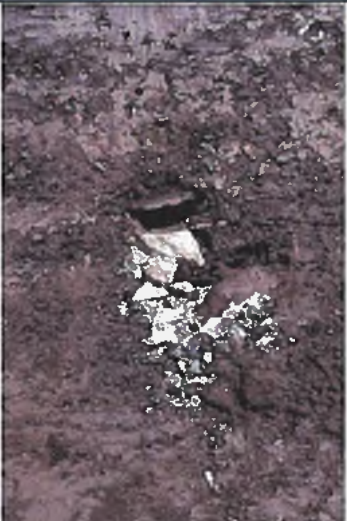
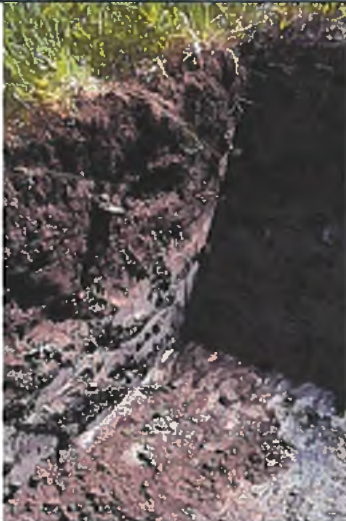
Test Pit ID: TP7-20 Date: 2020-05-20
Excavated by: Tomlinson Environmental Easting: 335402
Method: Kubota KX080 Track-mounted Excavator Northing: 4903148

Interval Depth (m bgs)	Stratigraphy	Sample				
		Topsoli Thickness (m)	Cover Soil Thickness (m)	Shelby Tube Sample Interval (m bgs)	Recovery (m)	Analyses
0 - 0.60	TOPSOIL - some fill, silt, clay and wood trace plastics. Rooting extends to 0.25m	0.60				
0.60-1.35	CLAY- brown, grey. Dry.		0.75			
Comments:						
Grassy surface. Garbage at 1.35m. Grab samples collected from 0.20 - 0.40 m bgs and 0.80 - 1.00 m bgs.						
Photos:

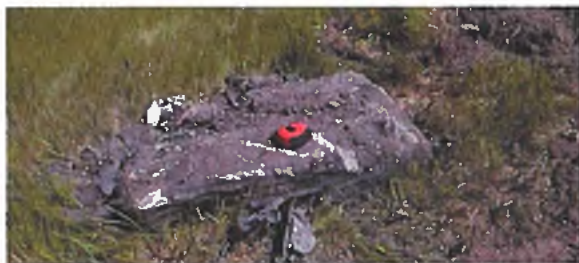
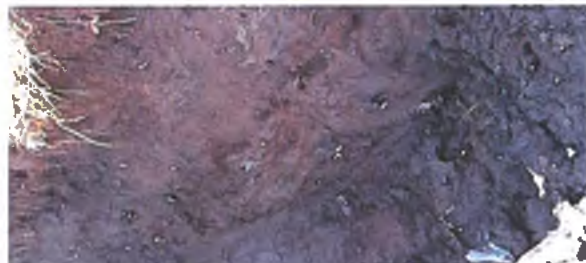
Test Pit ID: TP8-20 Date: 2020-05-20
Excavated by: Tomlinson Environmental Easting: 335374
Method: Kubota KX080 Track-mounted Excavator Northing: 4903071

Interval Depth (m bgs)	Stratigraphy	Sample				
		Topsoil Thickness (m)	Cover Soil Thickness (m)	Shelby Tube Sample Interval (m bgs)	Recovery (m)	Analyses
0 - 0.26	TOPSOIL - root system extending to 0.20m	0.26				
0.26-0.80	FILL- Brown/grey/black fill with silty clay and gravel.		1.30			
0.80-1.56	CLAY- Grey, some garbage (plastic and metal)

Grassy surface. Dug through big "O" drainage pipe surrounded by clear stone gravel at 0.90m depth. Large boulder also located at this depth. Repair made to big "O" pipe on May 21st. Grab samples collected from 0.35-0.60 m bgs and 1.10-1.40 m bgs.

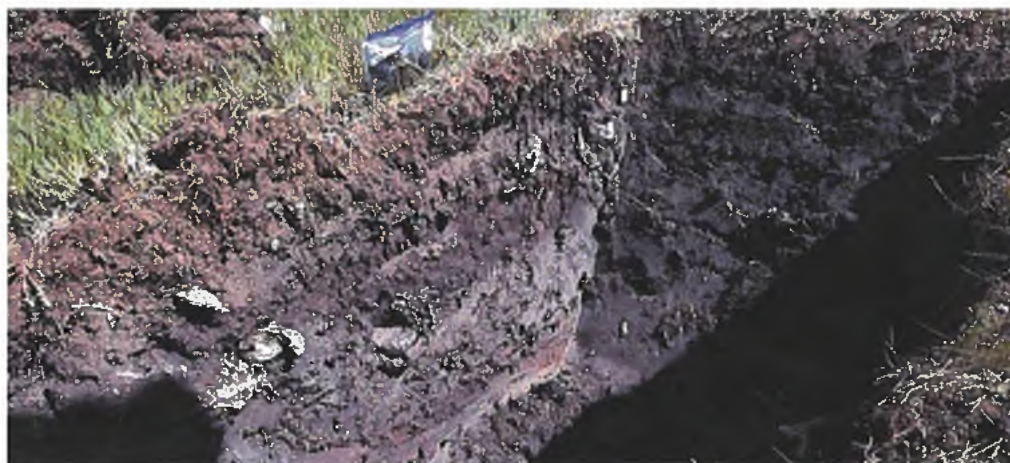
Test Pit ID: TP9-20 Date: 2020-05-20
Excavated by: Tomlinson Environmental Easting: 335265
Method: Kubota KX080 Track-mounted Excavator Northing: 4903051

Interval Depth (m bgs)	Stratigraphy	Sample				
		Topsoli Thickness (m)	Cover Soil Thickness (m)	Shelby Tube Sample Interval (m bgs)	Recovery (m)	Analyses
0 - 0.25	TOPSOIL - trace garbage. Root system extending to 0.30m.	0.25				
0.25-0.65	FILL- Brown fill with silt, clay and garbage (plastic).		1.02	0.0-0.70m	0.29	Grain size (sieve/hydrometer), Density/Natural Moisture Content
0.65-1.27	CLAY- Grey, some garbage (plastic).			0.70-1.40m	0.19	Density/Natural Moisture Content

Grassy surface. Grab samples from 0.20-0.80m bgs and 1.10-1.40m bgs.

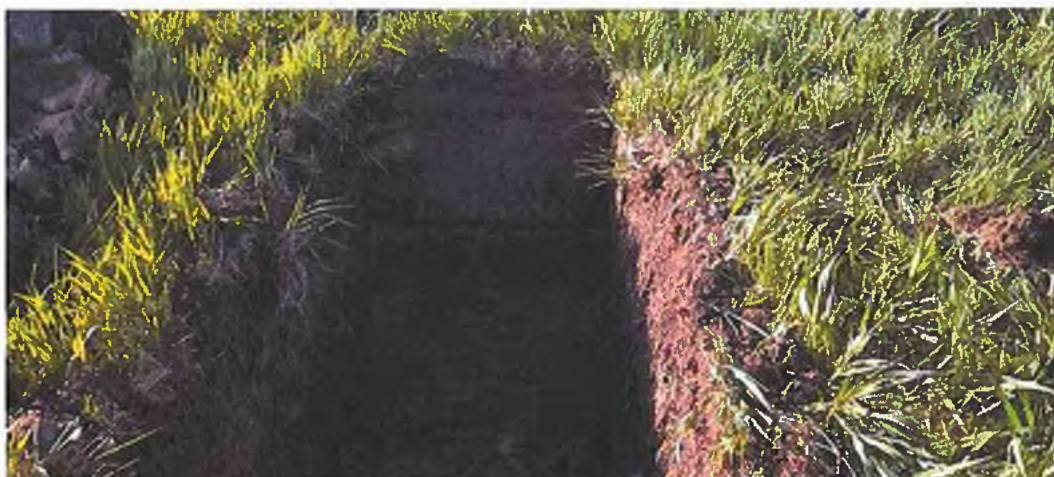
Test Pit ID: TP10-20 Date: 2020-05-21
Excavated by: Tomlinson Environmental Easting: 335304
Method: Kubota KX080 Track-mounted Excavator Northing: 4903125

Interval Depth (m bgs)	Stratigraphy	Sample				
		Topsail Thickness (m)	Cover Soil Thickness (m)	Shelby Tube Sample Interval (m bgs)	Recovery (m)	Analyses
0 - 0.24	TOPSOIL - root system extending to 0.50m	0.24				
0.24-0.67	SILTY CLAY- Brown, grey, blocky. Dry.		1.46			
0.67-1.70	CLAY- Brown, stiff. Dry. Ended hole at 1.70m bgs (no garbage encountered)					Grain size (sieve/hydrometer)

Grassy surface with some vegetative stress and slight depression. Grab samples collected at 0.35-0.55 m bgs and 1.10-1.40 m bgs.

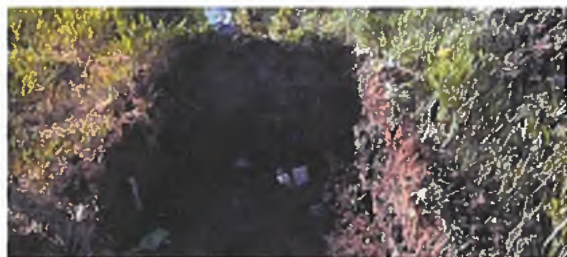
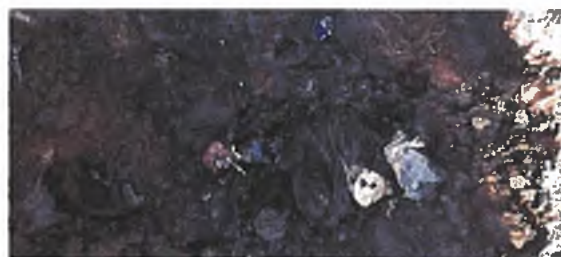
Test Pit ID: TP11-20 Date: 2020-05-21
Excavated by: Tomlinson Environmental Easting: 335207
Method: Kubota KX080 Track-mounted Excavator Northing: 4903056

Interval Depth (m bgs)	Stratigraphy	Sample				
		Topsail Thickness (m)	Cover Soil Thickness (m)	Shelby Tube Sample Interval (m bgs)	Recovery (m)	Analyses
0 - 0.12	TOPSOIL - root system extending to 0.15m.	0.12		0-0.70	0.25	Density/Natural Moisture Content
0.12-0.60	SILTY CLAY- Grey, black fill with trace waste and trace gravel.		0.48

Grassy surface with some vegetative stress. Grab sample collected 0.20-0.40m bgs.

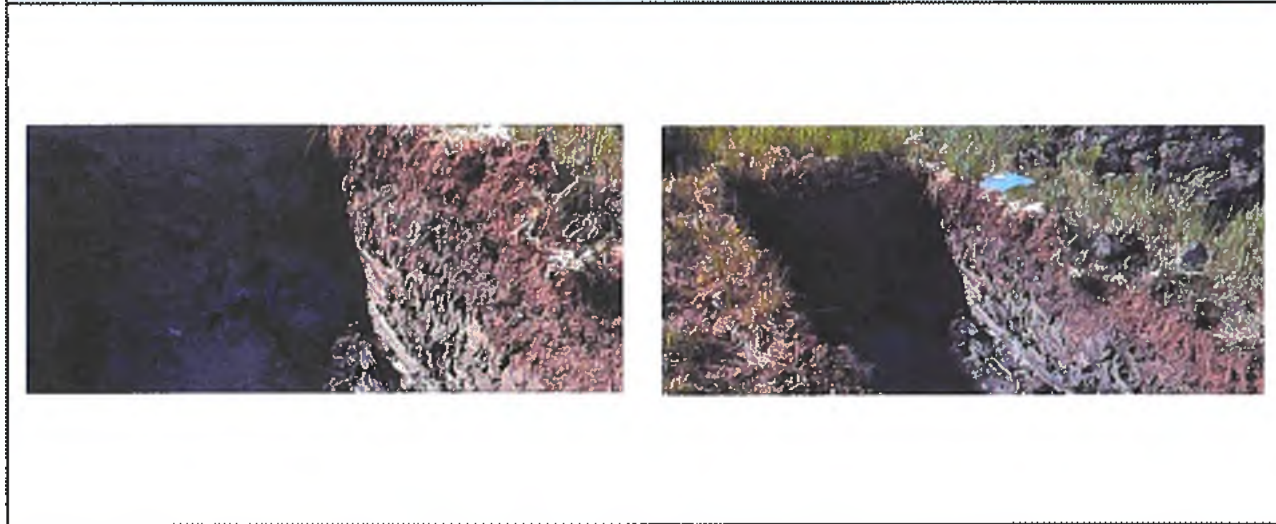
Test Pit ID: TP12-20 Date: 2020-05-21
Excavated by: Tomlinson Environmental Easting: 335132
Method: Kubota KX080 Track-mounted Excavator Northing: 4903047

Interval Depth (m bgs)	Stratigraphy	Sample				
		Topsail Thickness (m)	Cover Soil Thickness (m)	Shelby Tube Sample Interval (m bgs)	Recovery (m)	Analyses
0 - 0.20	TOPSOIL - Brown topsoil. Root system extending to 0.25m. Dry.	0.2				
0.20-0.40	SILTY CLAY- Brown, grey. Blocky. Dry.		0.7			
0.40-0.90	CLAY- Grey. Moist. Garbage encountered at 0.90m.

Comments:
Vegetation stress at surface in an area with visible settlement/depression. Ended hole at 0.90m in waste. Seepage observed at bottom of test pit.
Grab sample collected from 0.30-0.70m bgs.

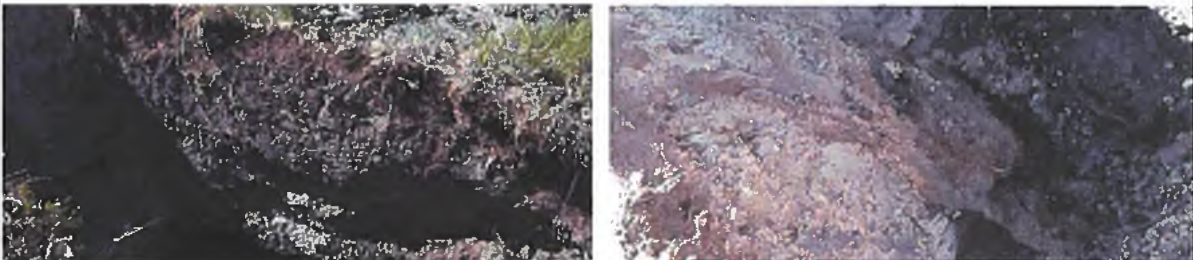
Test Pit ID: TP13-20 Date: 2020-05-21
Excavated by: Tomlinson Environmental Easting: 335145
Method: Kubota KX080 Track-mounted Excavator Northing: 4903004

Interval Depth (m bgs)	Stratigraphy	Sample				
		Topsoil Thickness (m)	Cover Soil Thickness (m)	Shelby Tube Sample Interval (m bgs)	Recovery (m)	Analyses
0 - 0.14	TOPSOIL - Brown, Dry.	0.14				
0.14-1.14	TILL- Soft, sandy and silty with some gravel and cobbles. Wet with water seepage into test pit. Black decomposed garbage encountered at 1.14m.		1.00	0.0-0.70	0.22	Density/Natural Moisture Content
				0.70-1.40	0.43	Hydraulic Conductivity (flexible wall permeameter), Density/Natural Moisture Content
Comments:						
Grassy surface with some vegetative stress (brown).						
Photos:

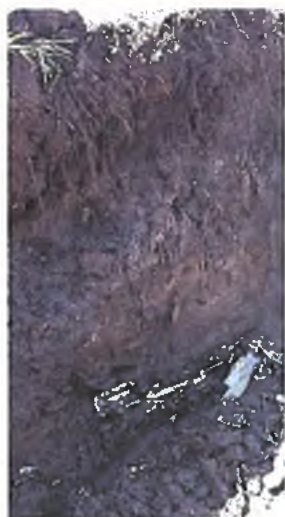
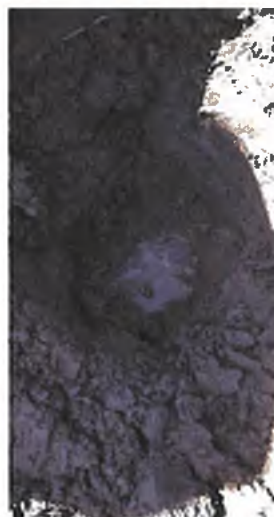
Grassy surface with vegetative stress (brown). Grab sample collected from 0.30-0.40 m bgs.

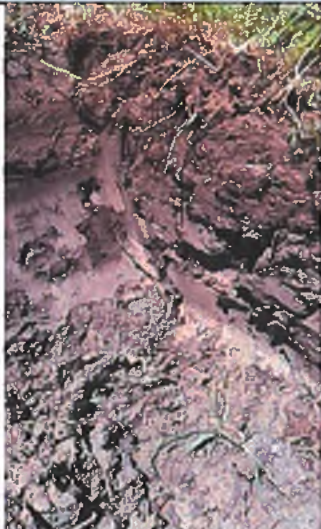
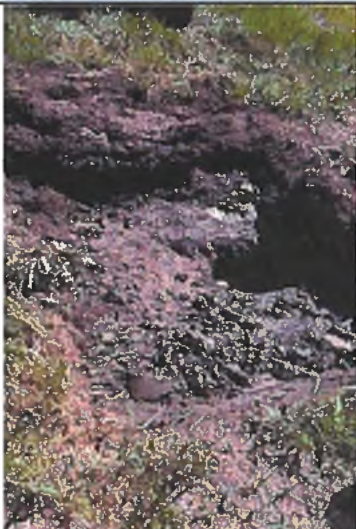
Test Pit ID: TP18-20 Date: 2020-05-21
Excavated by: Tomlinson Environmental Easting: 335423
Method: Kubota KX080 Track-mounted Excavator Northing: 4902924

Interval Depth (m bgs)	Stratigraphy	Sample				
		Topsail Thickness (m)	Cover Soil Thickness (m)	Shelby Tube Sample Interval (m bgs)	Recovery (m)	Analyses
0 - 0.20	TOPSOIL - Brown. Root system extending to 0.25m. Dry.	0.20				
0.20-0.70	CLAY - Grey, brown with silt. Blocky. Test hole ended so hole did not fill with water.		>0.50			Grain size (sieve/hydrometer)
Comments: Area with stressed vegetation and active seep with venting landfill gas (gas and water bubbling up through soils to surface). Grab sample collected from 0.30-0.50m bgs.						
Photos: <div>

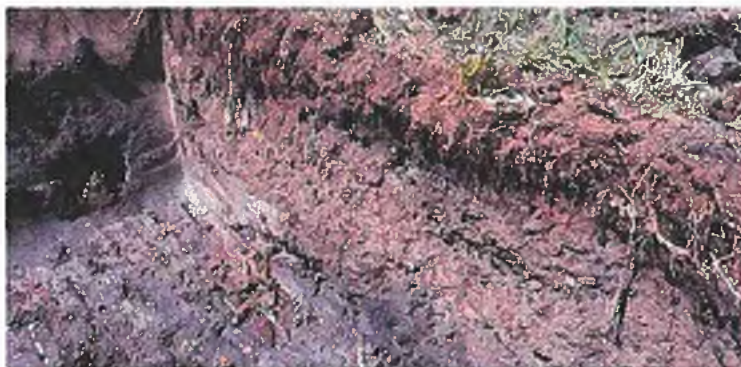
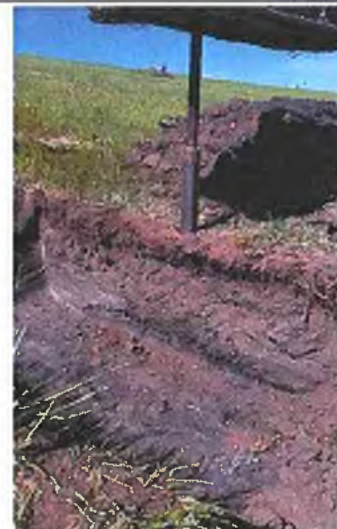
Grassy surface with healthy vegetation. Grab sample collected from 0.30-0.40 m bgs. Shelby tube slipped during initial sampling attempt; cleaned and re-used.

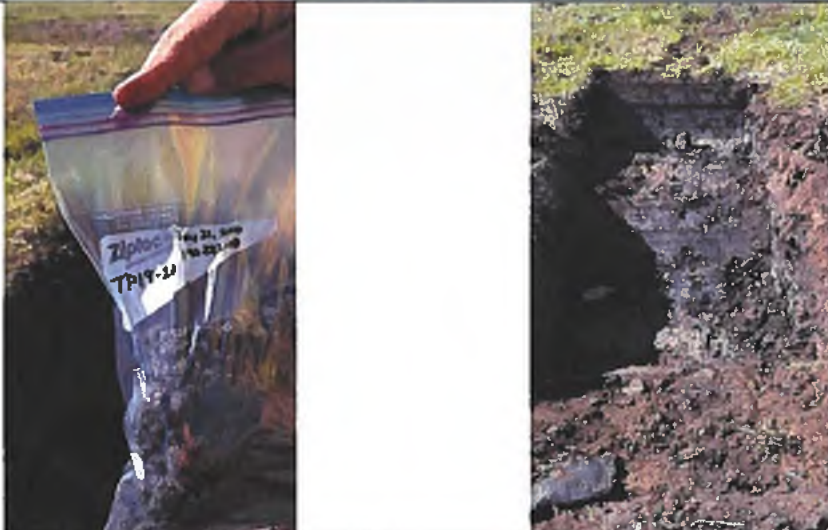
Test Pit ID: TP19-20 Date: 2020-05-21
Excavated by: Tomlinson Environmental Easting: 335204
Method: Kubota KX080 Track-mounted Excavator Northing: 4902831

Interval Depth (m bgs)	Stratigraphy	Sample				
		Topsoil Thickness (m)	Cover Soil Thickness (m)	Shelby Tube Sample Interval (m bgs)	Recovery (m)	Analyses
0 - 0.15	TOPSOIL - Grass over topsoil, root system extending to 0.20m. Dry.	0.15		0.0-0.70	0.22	
0.15-0.65	CLAYEY SILT- Grey, dry, blocky. Trace gravel.		0.5			Grain size (sieve/hydrometer), Density/Natural Moisture Content
Comments: Area disturbed with surface cracking; Possible former repair area. Grab sample collected from 0.30-0.50 m bgs.						
Photos:

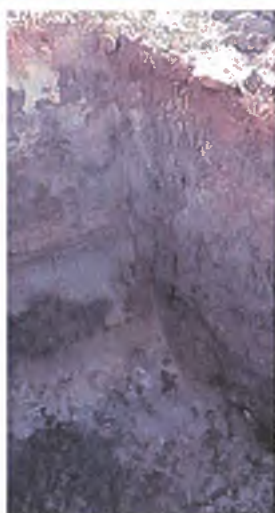
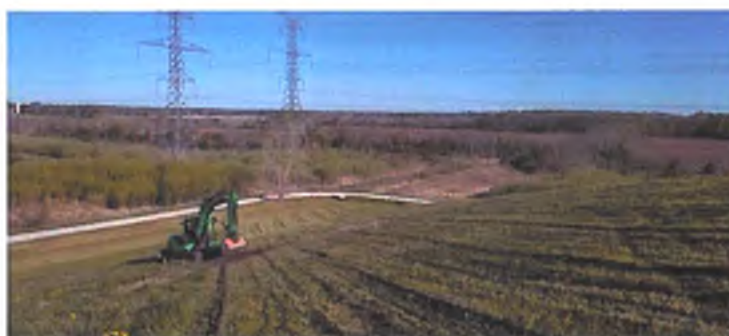
Test Pit ID: TP20-20 Date: 2020-06-21
Excavated by: Tomlinson Environmental Easting: 335067
Method: Kubota KX080 Track-mounted Excavator Northing: 4902992

Interval Depth (m bgs)	Stratigraphy	Sample				
		Topsoli Thickness (m)	Cover Soil Thickness (m)	Shelby Tube Sample Interval (m bgs)	Recovery (m)	Analyses
0 - 0.12	TOPSOIL - Dry. Root system extending to 0.22m.	0.12				
0.12-0.43	CLAYEY SILT - Grey, brown, Moist.		>1.18			
0.43-1.00	SILTY CLAY - Grey, brown, Moist.					
1.00-1.30	CLAYEY SILT - Grey with coarse gravel and cobbles.

Area with visible surface rutting and an exposed large cobble. Exposed 300mm vacuum line so test pit terminated. No damage to pipe (hand shoveled). No waste encountered. Grab sample collected from 0.50-0.80m bgs.

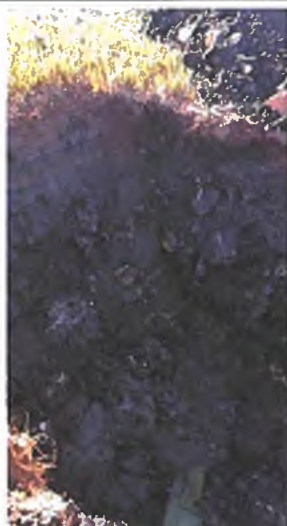
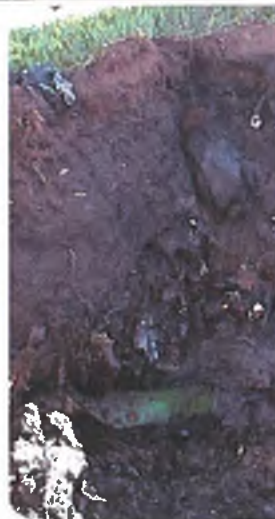
Grassy surface with stressed vegetation (brown) in disturbed area with coarse stones showing. Grab sample collected at 0.20-0.30 m bgs. See page observed into test pit at depth of 0.30 m.

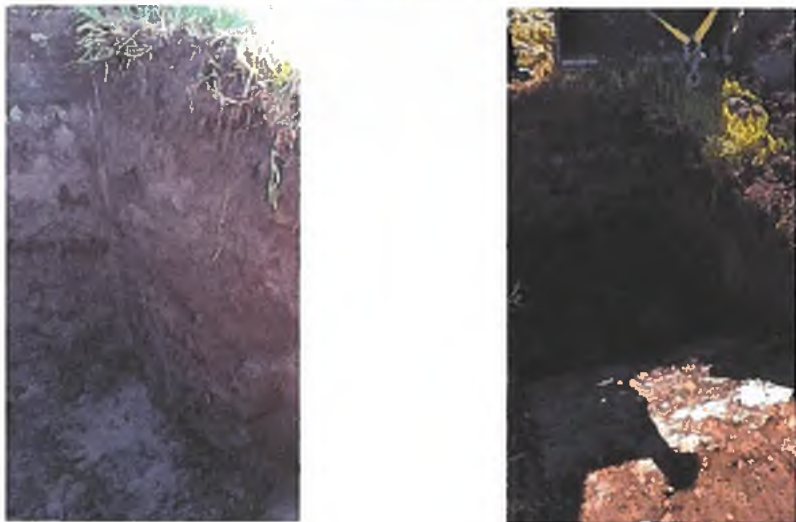
Test Pit ID: TP23-20 Date: 2020-05-21
Excavated by: Tomlinson Environmental Easting: 335171
Method: Kubota KX080 Track-mounted Excavator Northing: 4902937

Interval Depth (m bgs)	Stratigraphy	Sample				
		Topsoil Thickness (m)	Cover Soil Thickness (m)	Shelby Tube Sample Interval (m bgs)	Recovery (m)	Analyses
0 - 0.30	TOPSOIL - Silty sand with some gravel, brown. Dry. Root system extending to 0.50m.	0.3				
0.30-1.50	SILTY CLAY- Stiff, grey, brown, blocky. Moist. Increasing moisture and softer with depth.		>1.2			
Comments:						
Grassy surface with healthy vegetation in an area with a small depression. Garbage not encountered in test pit. Grab sample collected from 0.50-0.90m bgs.						
Photos:

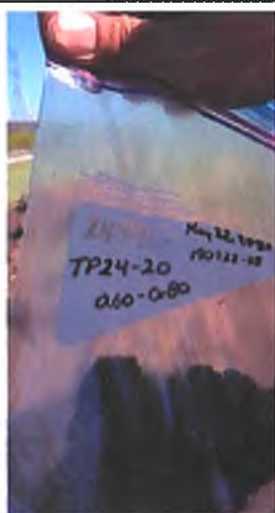
Test Pit ID: TP24-20 Date: 2020-05-21
Excavated by: Tomlinson Environmental Easting: 335098
Method: Kubota KX080 Track-mounted Excavator Northing: 4902844

Interval Depth (m bgs)	Stratigraphy	Sample				
		Topsoil Thickness (m)	Cover Soil Thickness (m)	Shelby Tube Sample Interval (m bgs)	Recovery (m)	Analyses
0 - 0.16	TOPSOIL - Brown with sand and gravel. Root system extending to 0.25m.	0.16				
0.16-0.40	CLAYEY SILT - Grey, blocky, moist.		0.94			
0.40-1.10	FILL - Sandy silt with gravel, wood debris and garbage.

Grassy surface with stressed (brown) vegetation and visible coarse stones showing. Garbage encountered at a depth of 1.10m. Grab samples collected from 0.20-0.30m bgs and 0.60-0.80m bgs.

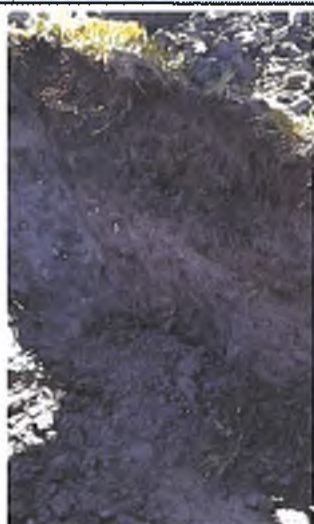
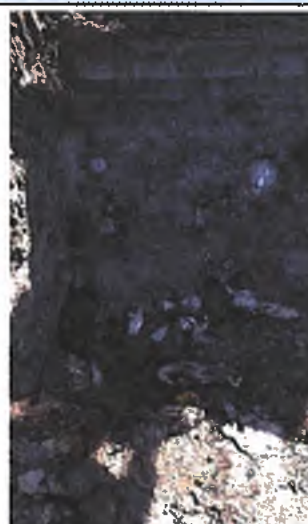
Photos:

Grassy surface with some vegetative stress and minor settlement/depression. Waste encountered at depth of 0.85m. Grab samples collected from 0.20-0.35m bgs and 0.50-0.80m bgs.
