MEMORANDUM

DATE: January 20, 2020
TO: Trevor Dagilis, District Manager, Ministry of the Environment, Conservation and Parks (MECP)
CC: David Arnott, Kyle Stephenson, Shawn Trimper and Peter Taylor (MECP)
Chris Prucha, Bill McDonough and Jim Forney (WM)
FROM: François Richard (BluMetric)
PROJECT NO: 200172-03
SUBJECT: Notification of On-Site Leachate Release, WM Richmond Landfill, Town of Greater Napanee
Ref: MECP Spill Action Centre Reference Number: 5065-BKVRAQ

WASTE MANAGEMENT RICHMOND LANDFILL LEACHATE RELEASE INVESTIGATION

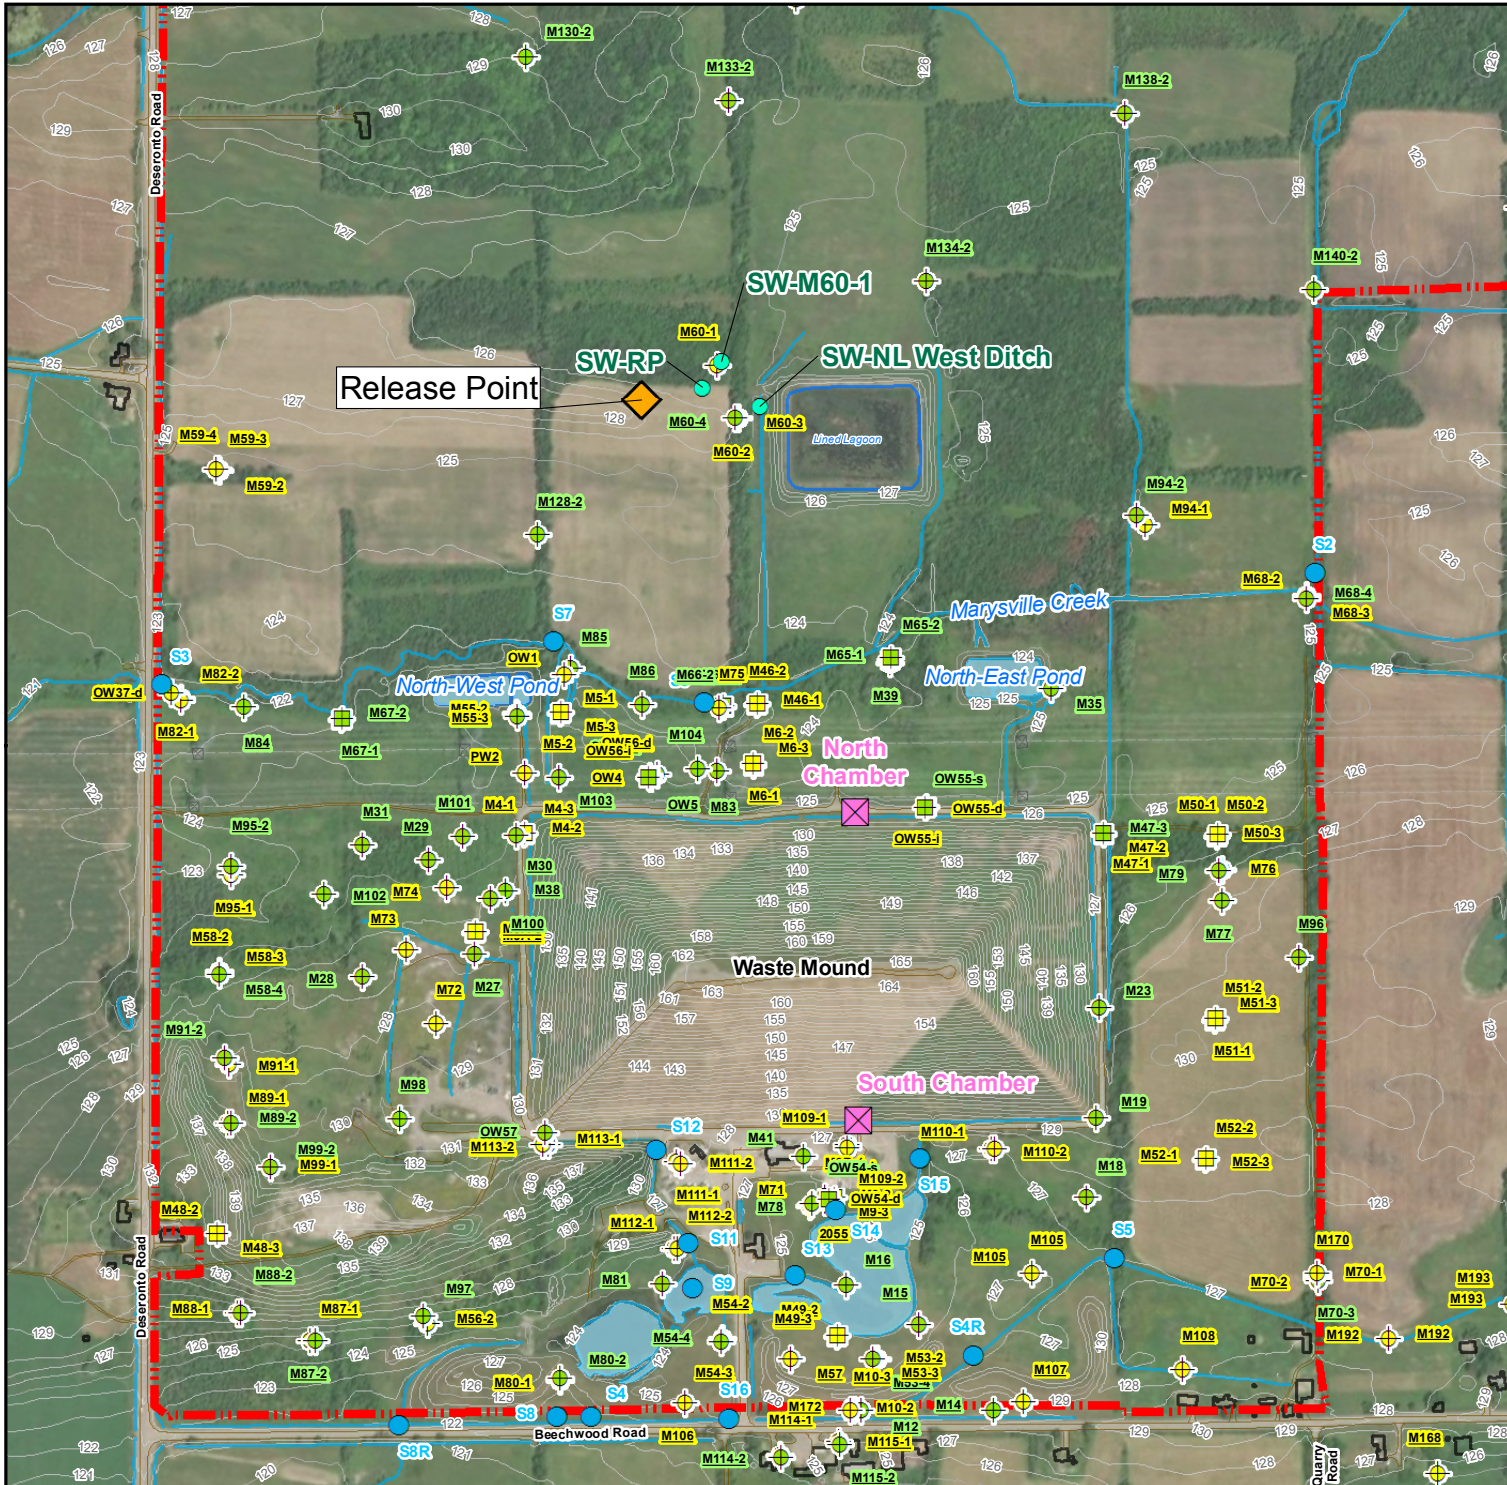
PROJECT # 200172-03	DATE January 20, 2020
DRAWN AL	CHECKED FR
FIG NO. 01	REV 0

A site plan and sampling locations are shown on Figure 1.

SITE PLAN AND MONITORING LOCATIONS

The Richmond Landfill is located at 1271 Beechwood Road, Napanee, and has been closed since June 30, 2011. Landfill leachate is collected from two collection points (North Chamber and South Chamber) located along the perimeter of the waste mound (see Figure 1). Leachate is typically hauled off-site for treatment at the Napanee Waste Water Treatment Plant (WWTP). On occasions when the WWTP is at capacity and cannot accept leachate from the site, leachate is pumped to the lined North Lagoon where it is stored temporarily, until such time as it can be hauled to the WWTP for treatment.

At approximately 10 AM on Tuesday January 14, 2020 approximately 3,500 gallons of leachate were spilled onto a wooded area of the Richmond Landfill property, shown on Figure 1. WM had loaded a tanker truck with approximately 3,500 gallons of leachate from the North Chamber leachate sump of the landfill. It was intended to go to the Napanee WWTP but the plant was not accepting leachate on Tuesday due to high rains over the weekend. WM's on-site operator directed the contractor to haul the load of leachate to the contingency North Lagoon (see Figure 1). As the tanker truck was driving across fields to get to the lagoon from the west, the ground was beginning to thaw and the driver was concerned he would get stuck. On-site personnel directed the contractor to back their truck to the edge of a wooded area and dump the 3,500 gallons of leachate.

BluMetric was instructed by WM to investigate the leachate release. On Thursday, January 16, 2020, field personnel went to the site to take pictures to document conditions in the area and to collect surface water samples in the vicinity of and downstream from the release point. Surface water drainage is inferred from ground surface topography to be towards the east-northeast from the release point. Samples were collected from ponded water along the assumed flow path at three locations, including near the release point, near monitoring well M60-1 and in the drainage ditch that runs to the south along the west side of North Lagoon; a sample was also collected from Marysville Creek at downstream sampling location S3. Additional samples were collected on Friday January 17, 2020 from the North Chamber sump, the Northeast and Northwest stormwater collection ponds, and downstream sampling location S8R located at the outlet from the south field stormwater collection pond system.

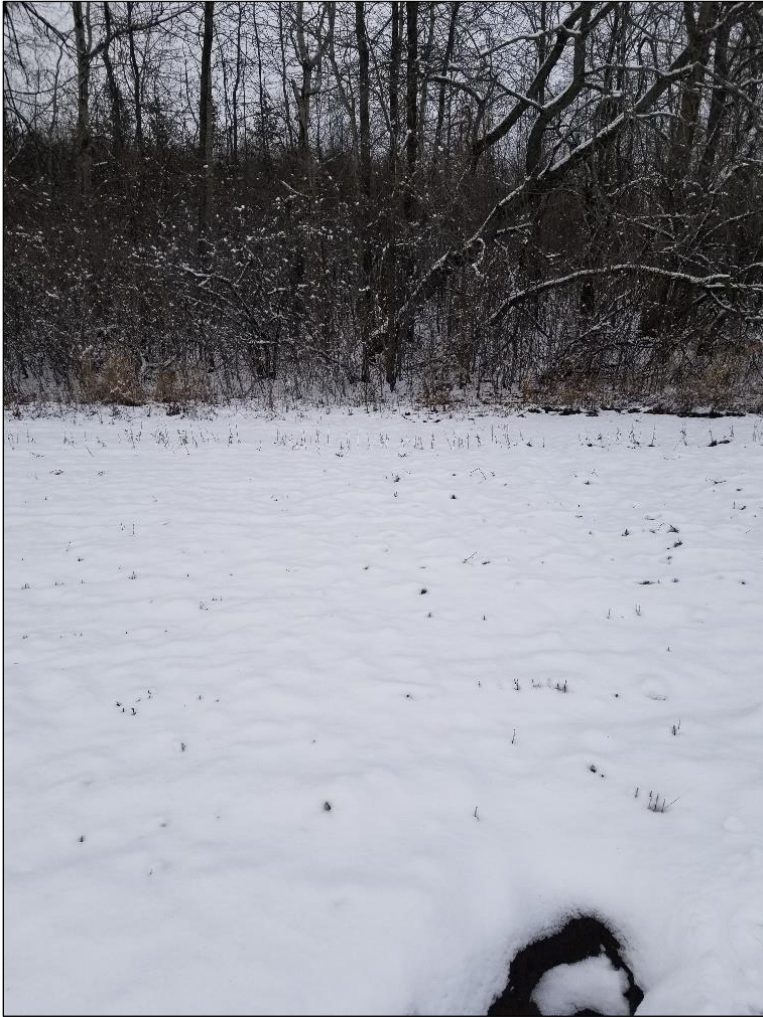
Release Point, looking north.

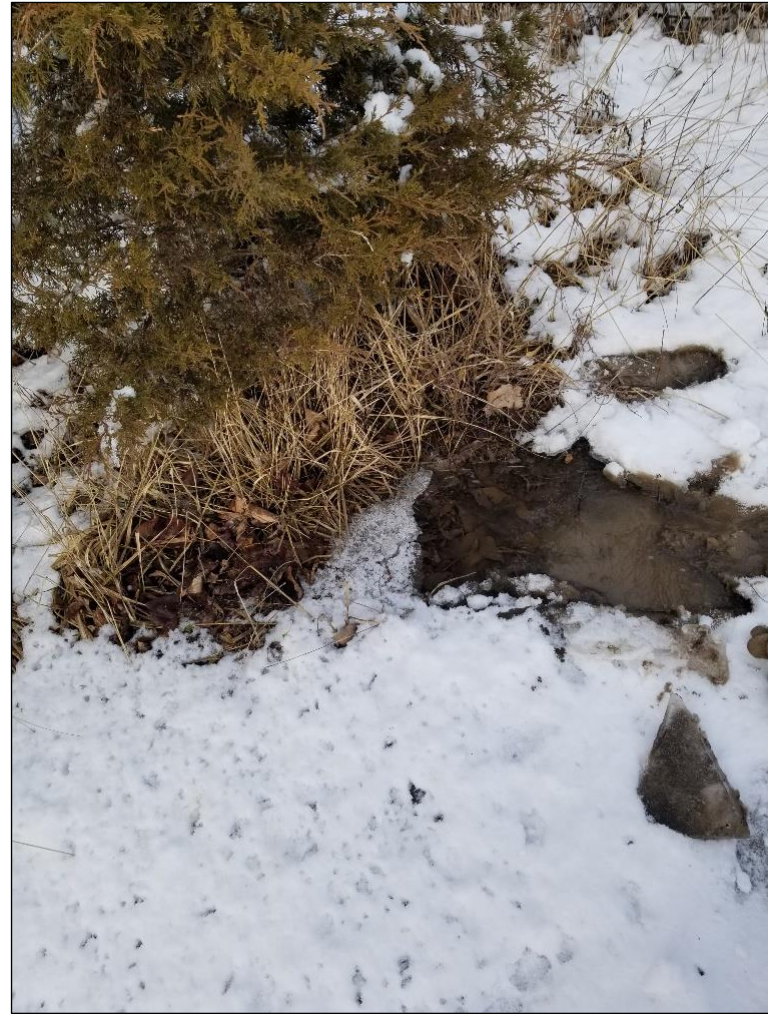
Release Ponding (Sampling Location SW-RP)

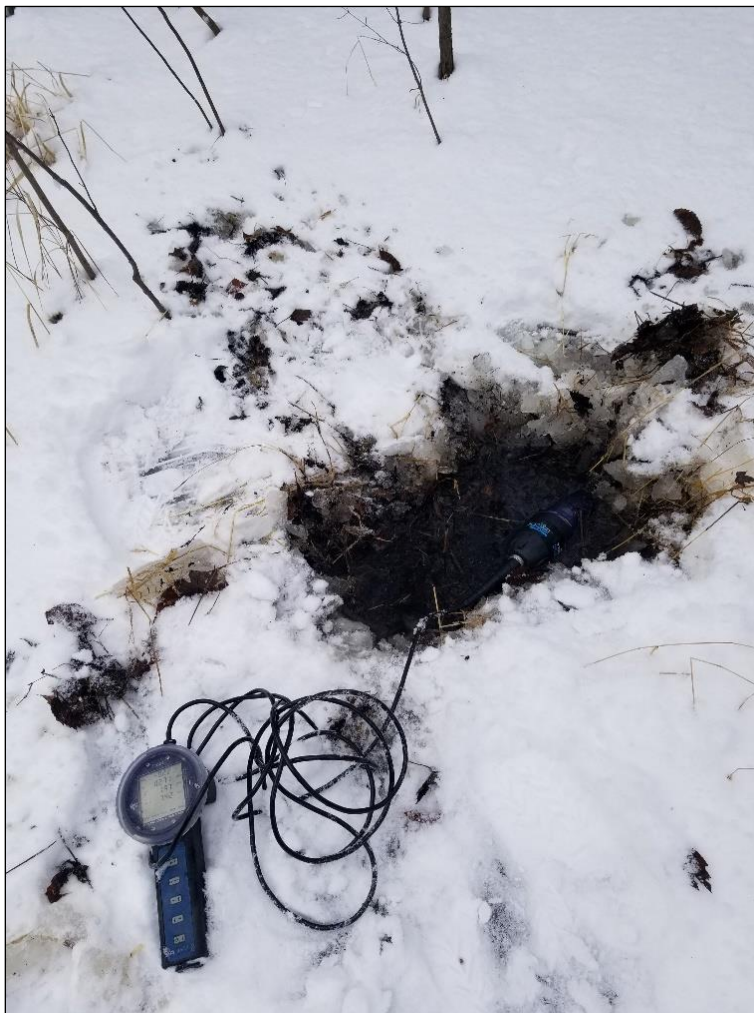
**Ponded water near monitoring well M60-1
(Sampling Location SW-M60-1).**

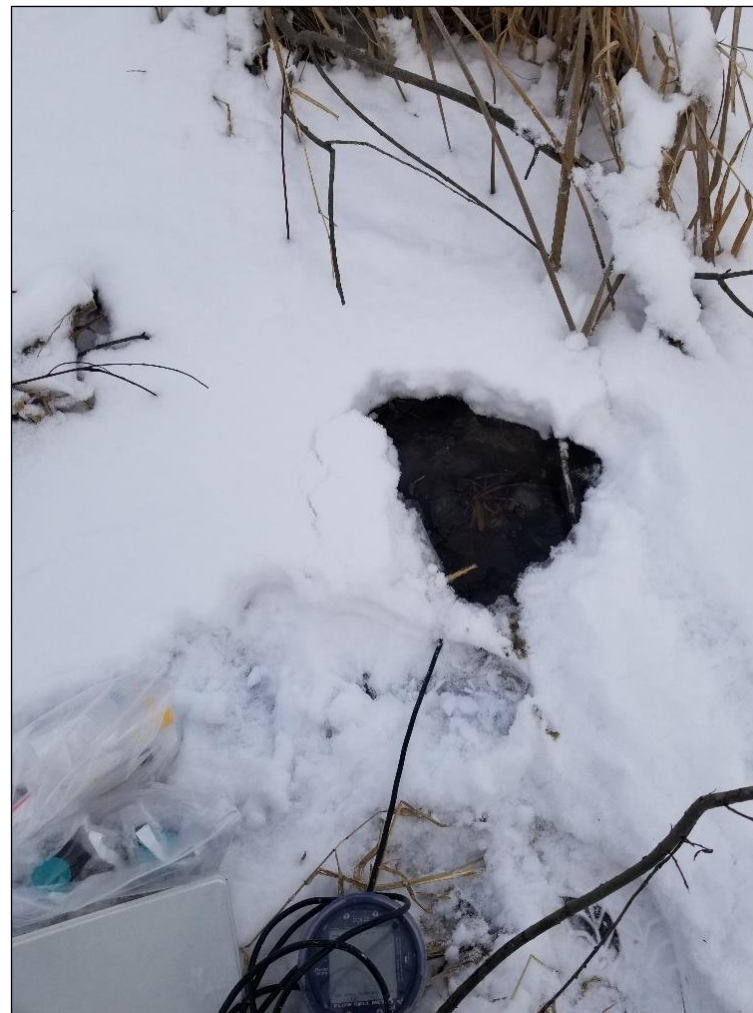
**Ditch flowing south along west side of N. Lagoon
(Sampling Location SW-NL)**
