**SPRING 2021
SEMI-ANNUAL MONITORING REPORT**

**WASTE MANAGEMENT OF CANADA
RICHMOND LANDFILL
TOWN OF GREATER NAPANEE, ONTARIO**

Project Number: 210166-03
14 July 2021

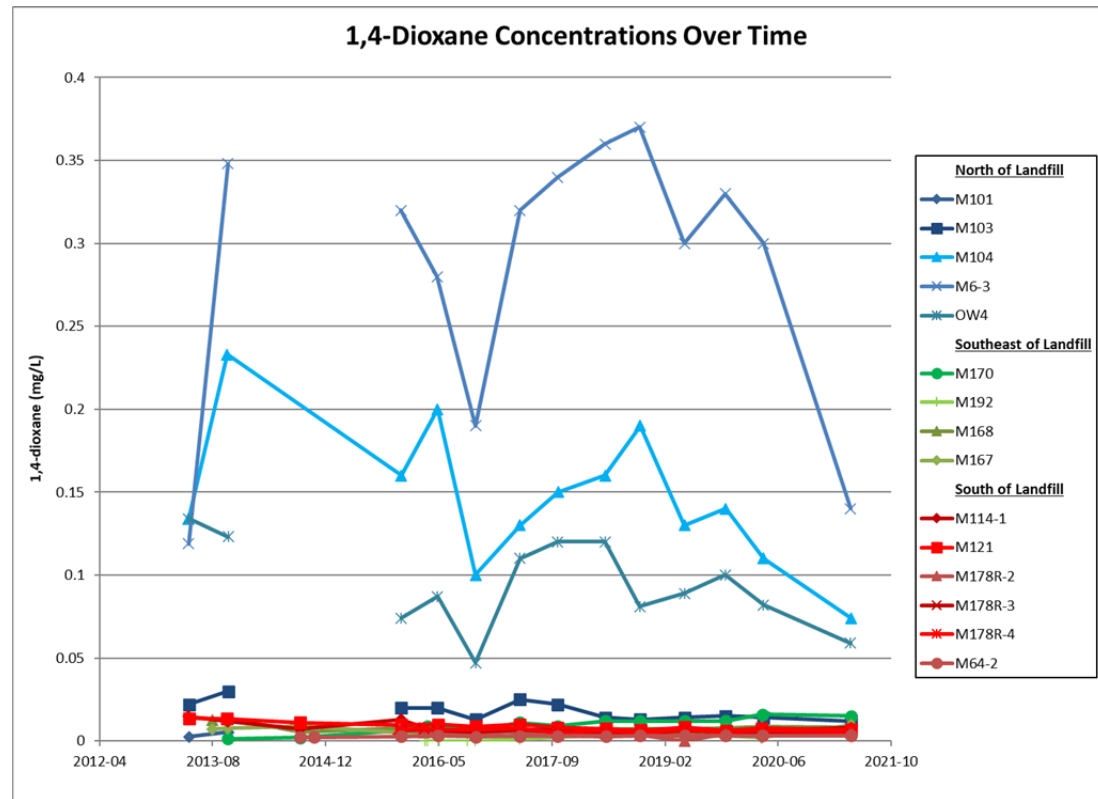
- A) Concentrations are significantly higher at monitoring wells M6-3, OW4 and M104, located adjacent to the north portion of the landfill, compared to all other monitoring locations. Details for the areas to the north (blue series), southeast (green series) and south (red series) of the landfill are shown on Plots B, C and D, respectively;

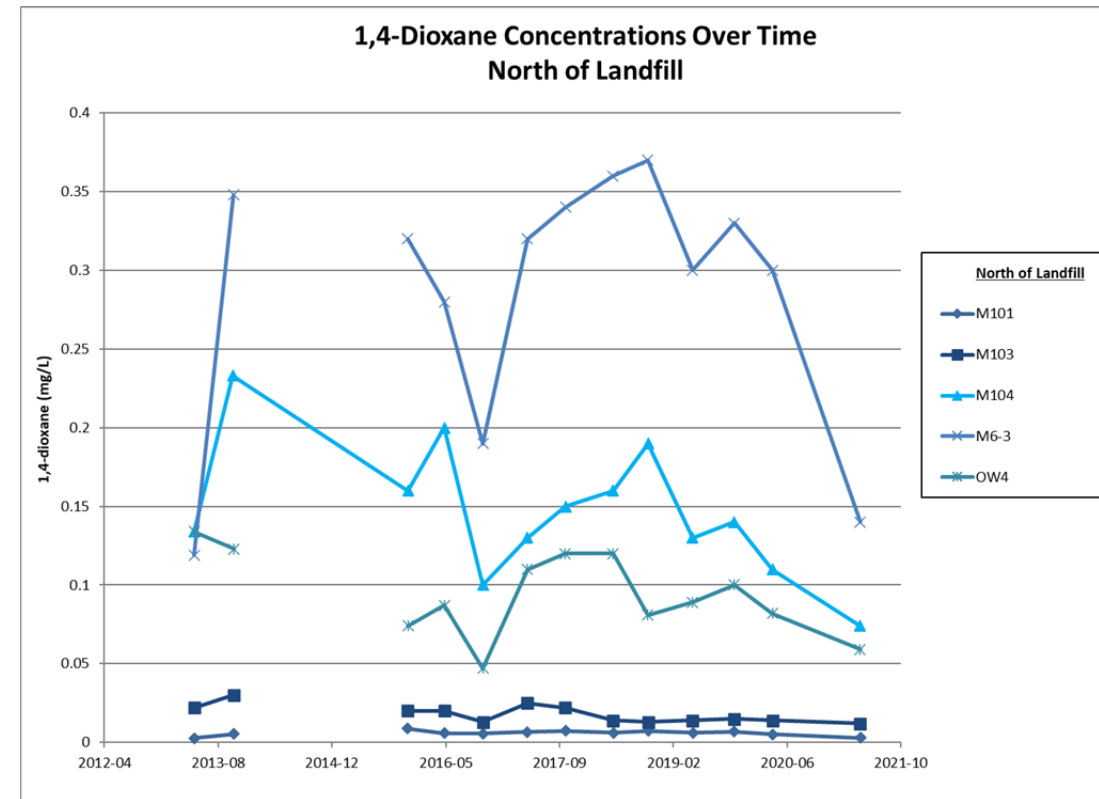
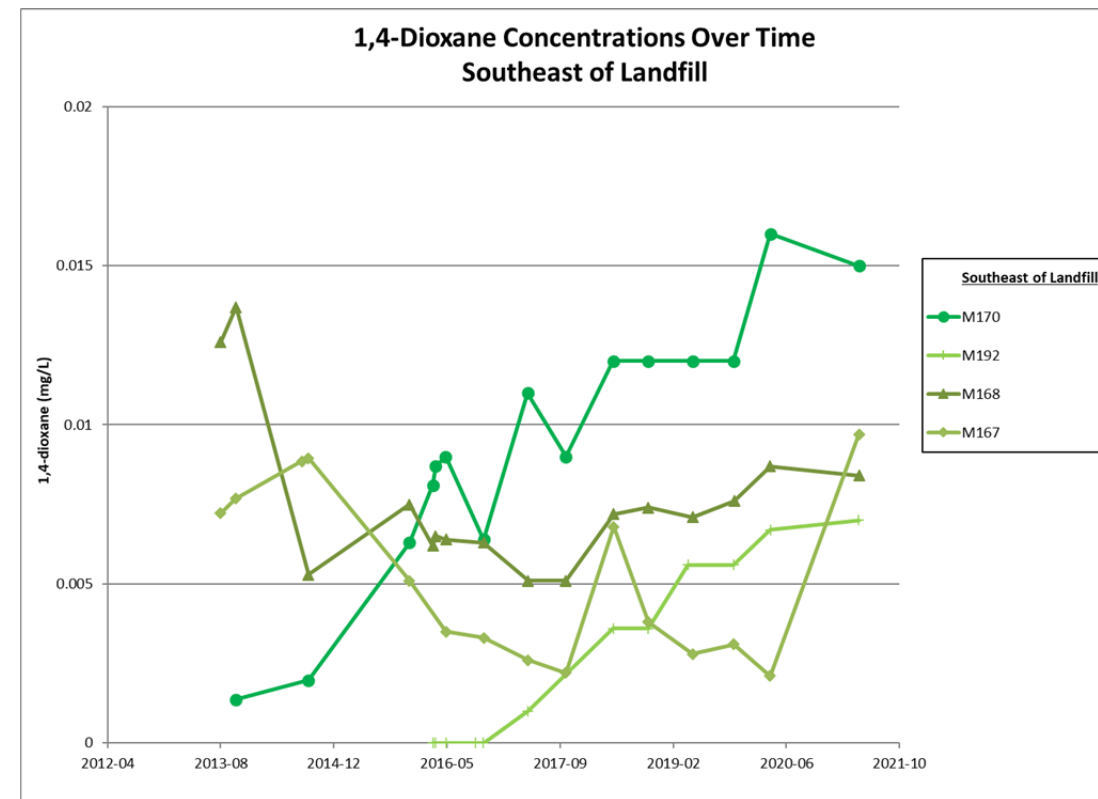
- B) To the north of the landfill, stable or declining (notably since 2018) trends are observed in the shallow groundwater flow zone (M101, M103 and M104) and intermediate bedrock flow zone (M6-3 and OW4);
- C) To the southeast of the landfill, increasing trends are observed at M170 and M192, and to a lesser degree at M168 located farther downgradient. The 1,4-dioxane concentration at M167 in spring 2021 was higher compared to recent results, but was consistent with the historical range of results at this location; and,
- D) To the south of the landfill, stable or declining trends are observed in the intermediate bedrock flow zone (M114-1, M121, M178R-2, M178R-3, M178R-4 and M64-2).

The stable and declining trends observed in 1,4-dioxane concentrations north and south of the landfill in both shallow and intermediate bedrock zones confirm that the plume is stable and naturally attenuating in these areas. With respect to the southeast portion of the property, WM has proposed to extend the eastern limit of the proposed Contaminant Attenuation Zone (CAZ) north of Beechwood Road by adding an area of approximately 20 acres east of the landfill property if an agreement can be reached with the property owner^(6,7). If such a negotiated agreement cannot be achieved, WM will implement an engineered solution located along the eastern landfill property limit.
